**West Lewis
Island Pastoral
Station
Excavation**

ALISTAIR PATERSON, ALEXANDER BURCHAM, ANNIE CARSON,
KEN MULVANEY, JO MCDONALD

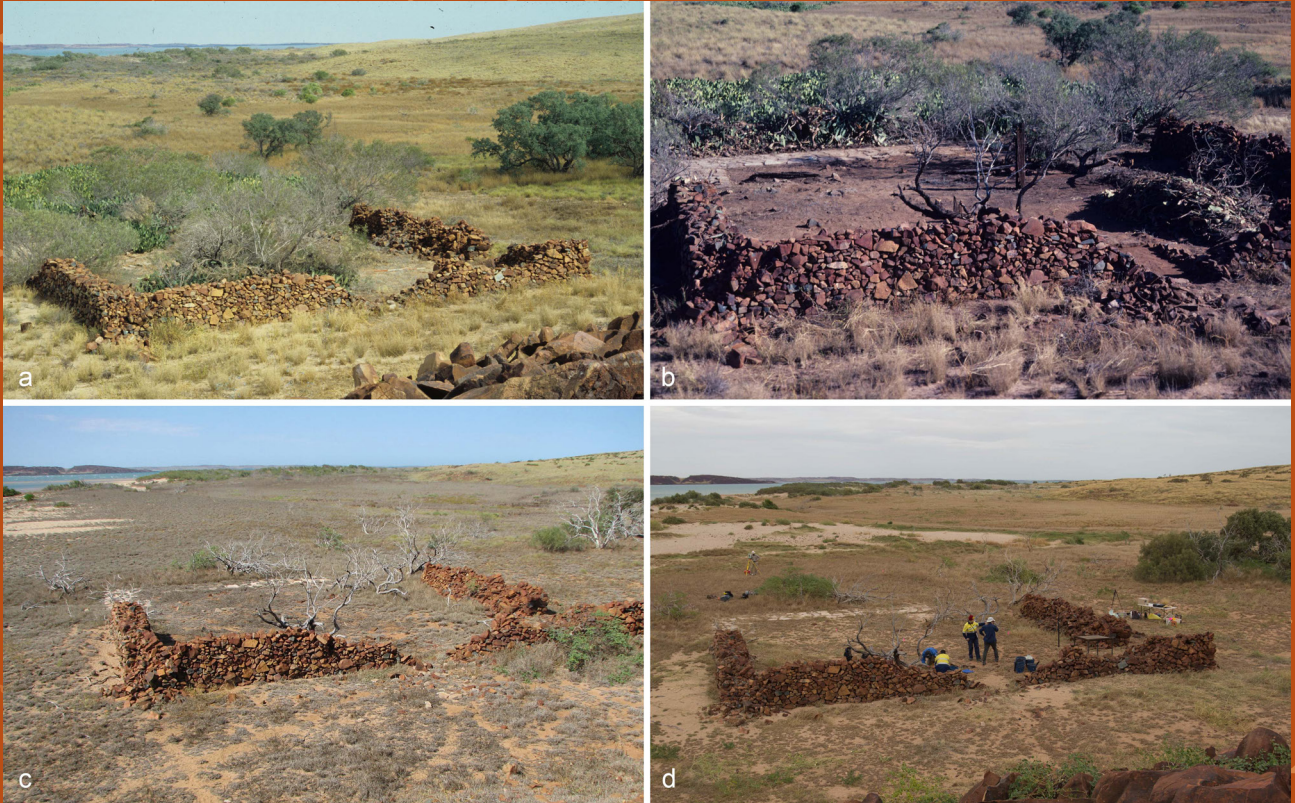
Figure 11.1. West Lewis Island settlement, Building 1, the main homestead structure: (a) in 1979 showing condition with bloodwoods and prickly pear; (b) following vegetation removal within the building walls, leaving the prickly pear behind the stone paving (both photos Jack McIlroy); (c) in 2006 with the prickly pear gone, along with the disappearance of the wooden posts (photo Ken Mulvaney); and (d) view taken in 2017 during current project.

In 1979 WAM again visited the island as part of a Historic Sites survey directed by Jack McIlroy (Figure 11.1) and organised by Hutchinson, who received a grant from the Australian Heritage Commission (McIlroy 1979). A search of the Australian Heritage Council records reveals no documentation of this trip, not even the original photographs. However, WAM holds objects collected by McIlroy in the 1970s in the History Collection

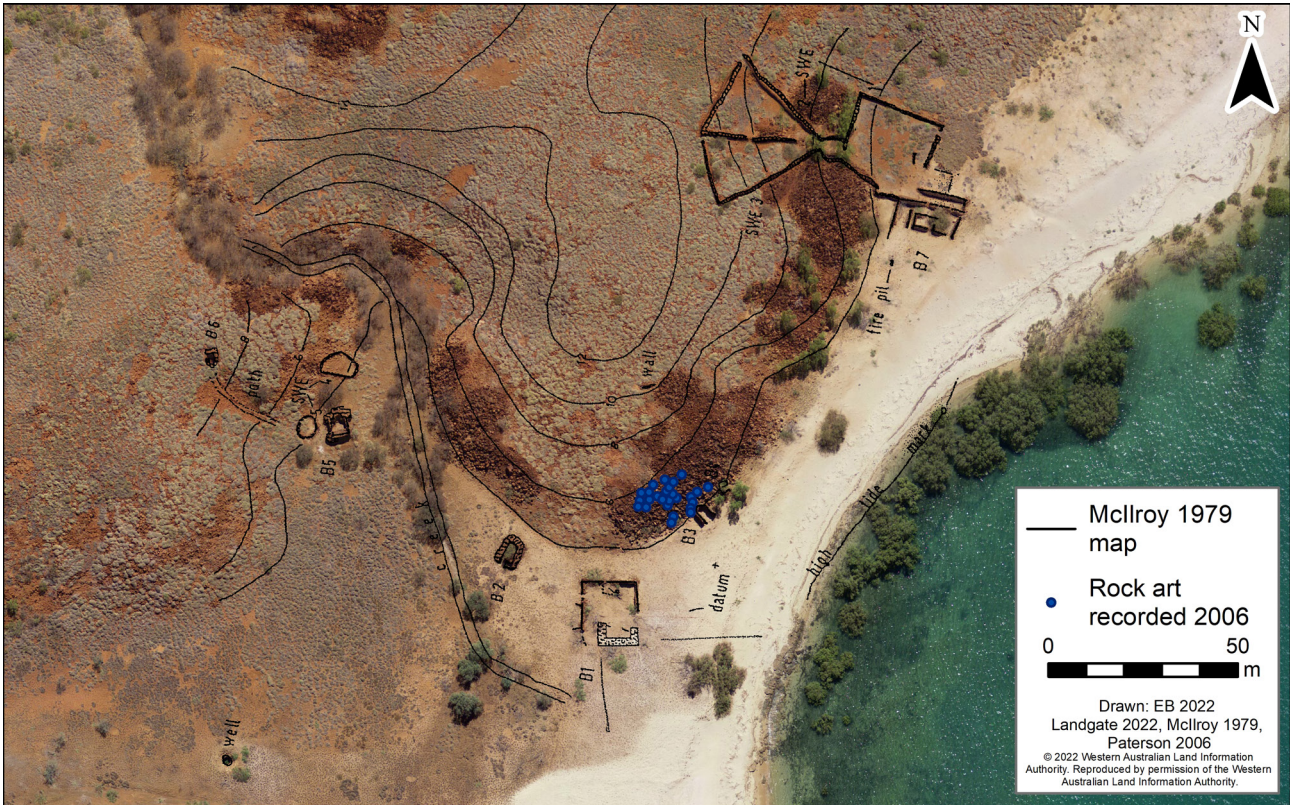
Figure 11.2. West Lewis sheep station buildings and environs with overlay of Mcllroy recording and rock art recording by Paterson (Paterson 2006: Figure 3).

Their site plan shows the structures and a concentration of rock engravings on a stone outcrop adjacent to the structures (Figure 11.2). They described the settlement thus:

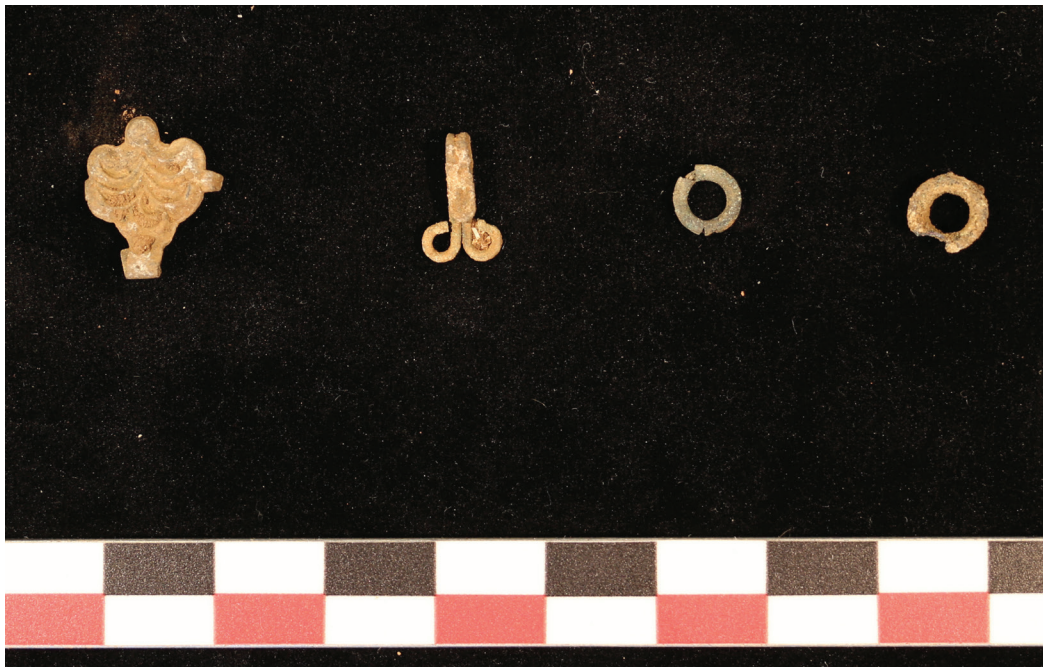
Figure 11.7. Personal adornment. From left: decorated clasp, small hook, and two eyelets.

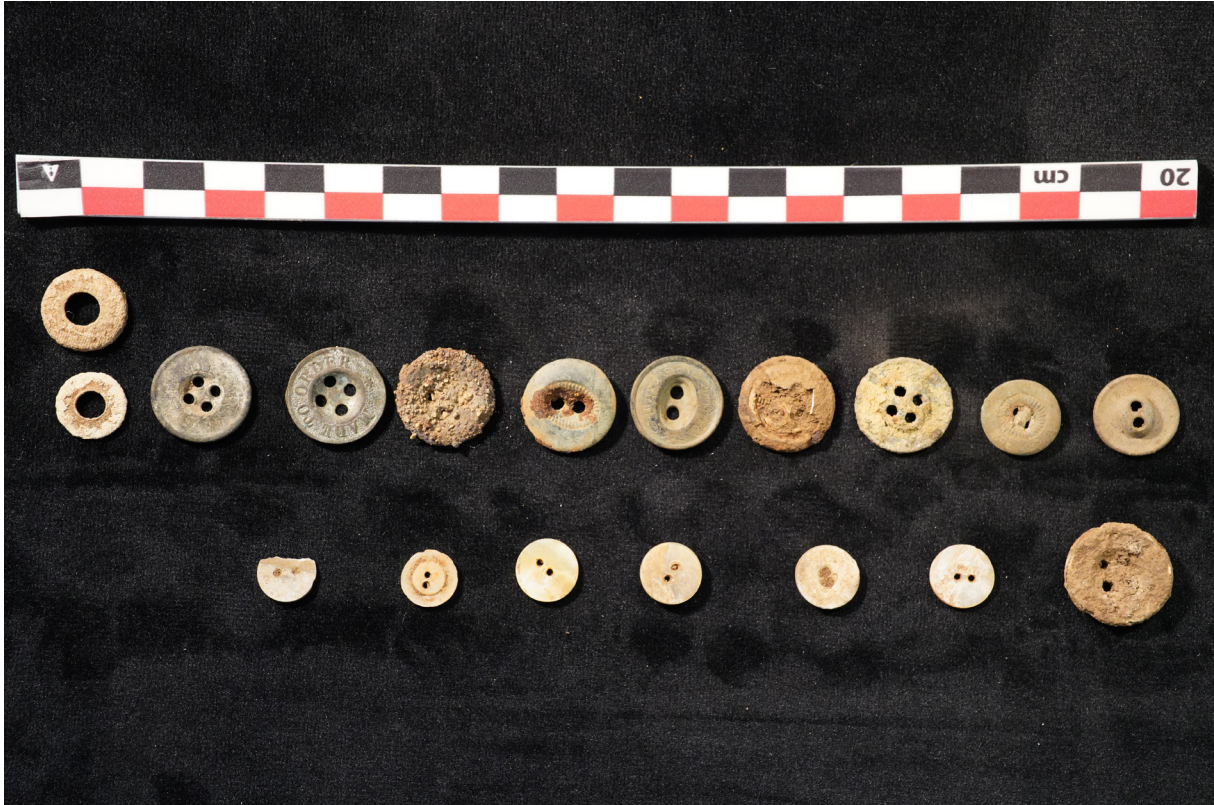
Figure 11.8. Top left: two halves of a grommet, typically used for canvas. Top row: range of 4-hole and 2-hole metal sew-through trouser buttons, typical after the 1850s, including one 'Made to Order' haberdashery brand. Fourth button from left is cloth-covered, likely for a jacket or coat. Lower row: 2-hole sew-through buttons of bone or mother-of-pearl, commonly used for shirts, and a 4-hole sew-through metal button.

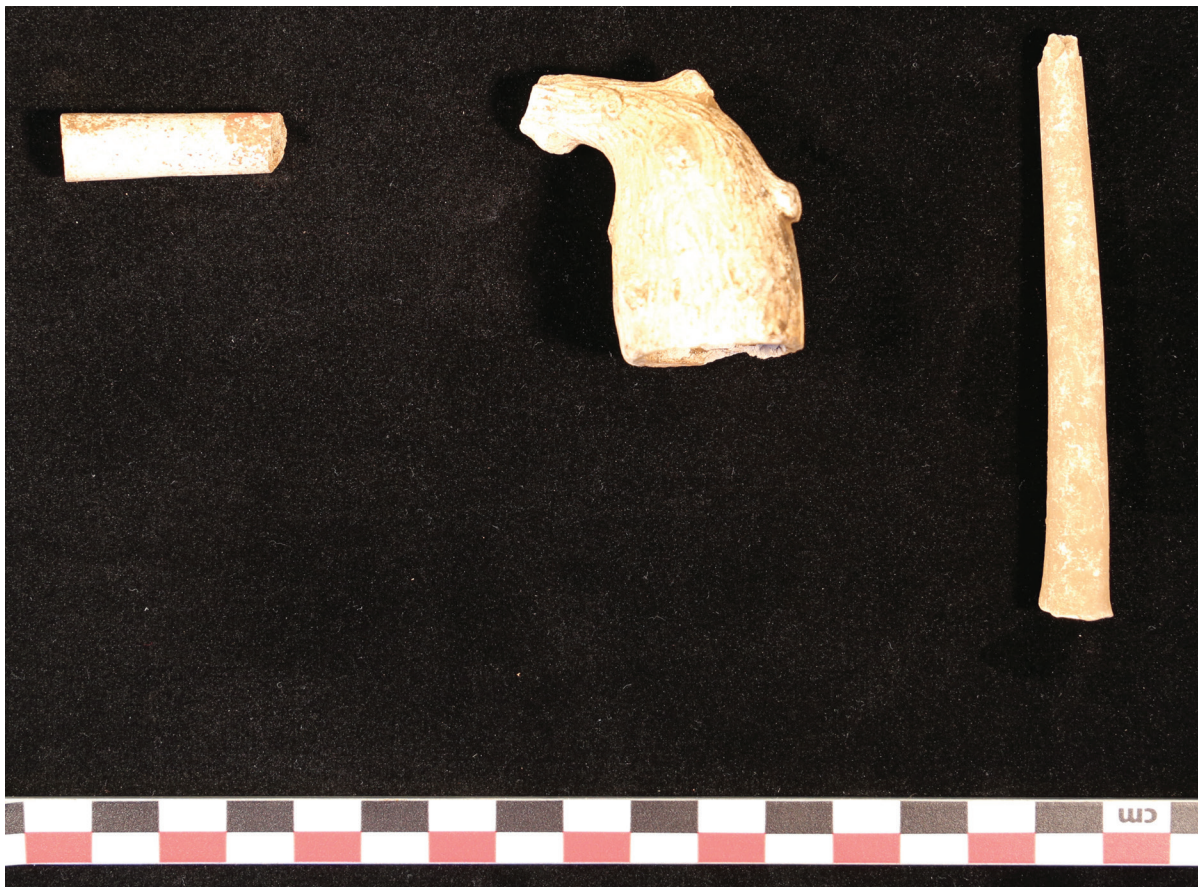
Figure 11.9. Clay smoking pipes: two stem fragments, and a bowl with wood decoration.

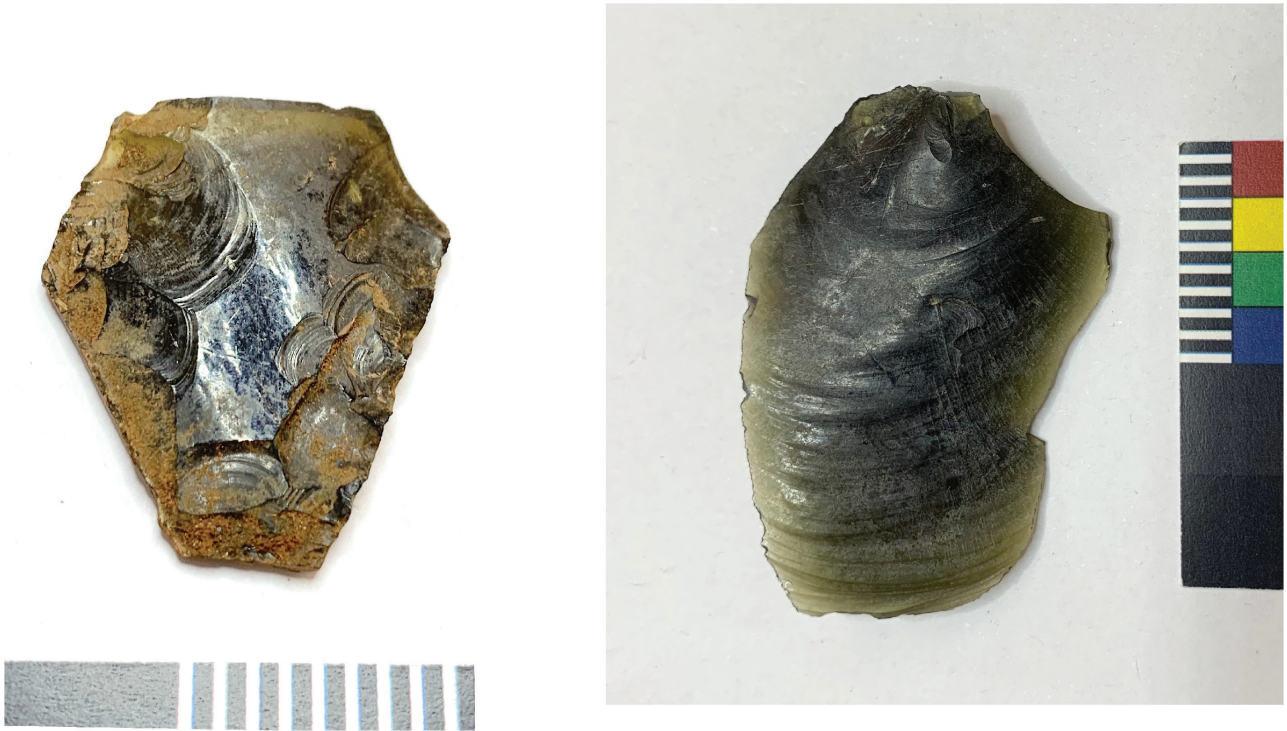
Figure 11.10. Modified glass artefacts. Left: olive glass fragment with 8 flake scars on one surface. Right: olive glass flake with diagnostic characteristics and possible evidence of use.

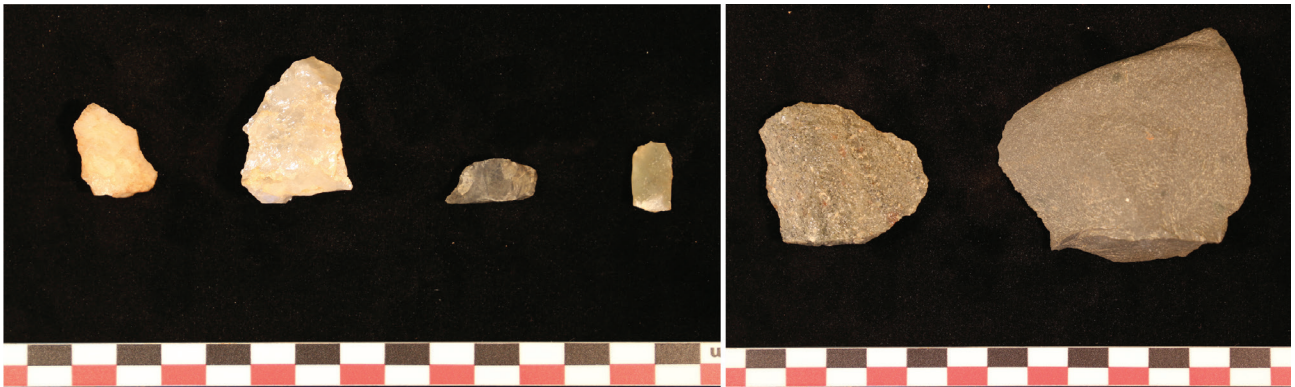
Figure 11.11. Lithics. Left: quartz flake, CF001-01; chalcedony flake, square 334243/XU3; quartz flake, square 334243/XU4; quartz flake, square 334243A/XU9. Right: two basalt flakes, Square 344243.

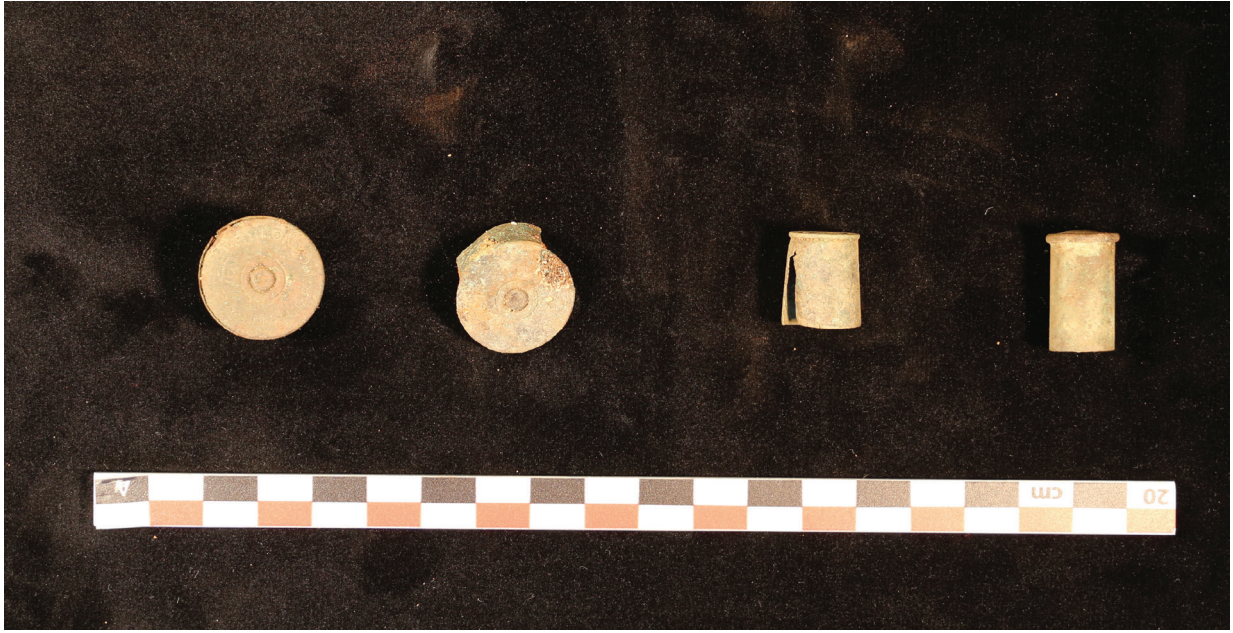
Figure 11.12. Munitions (from left) two cases for shotguns, possibly Ely type; (right) two bullet cases.

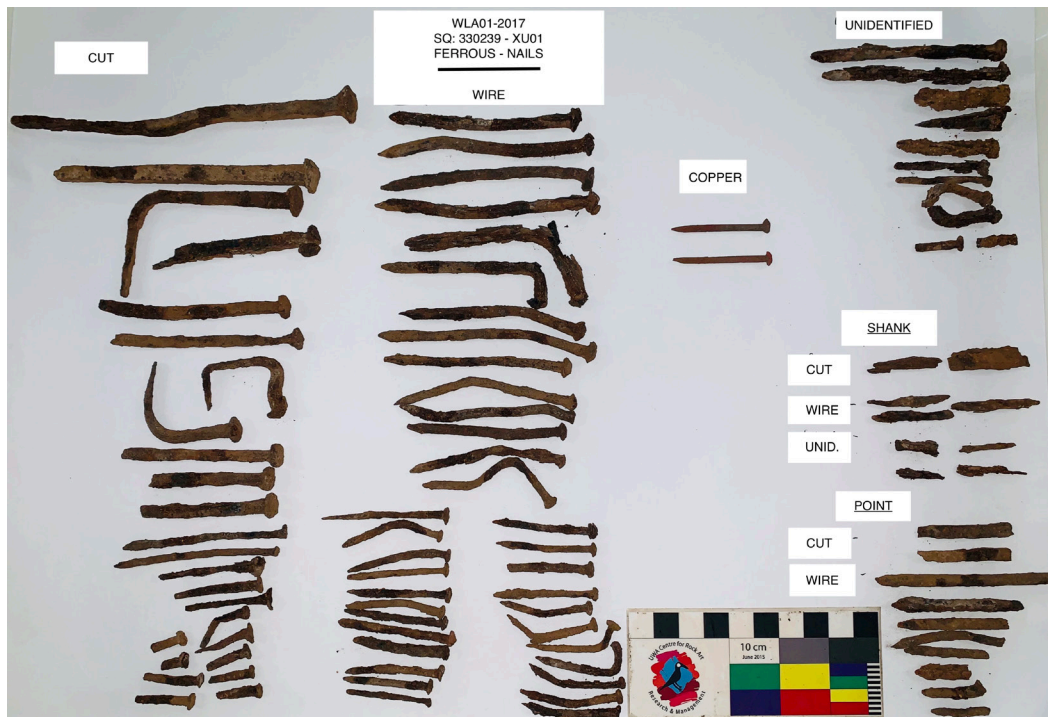
Figure 11.15. Range of nail types at the settlement (largely from Square 330239), including ferric cut, hand wrought and wire nails. Two copper nails, possibly from ship part.

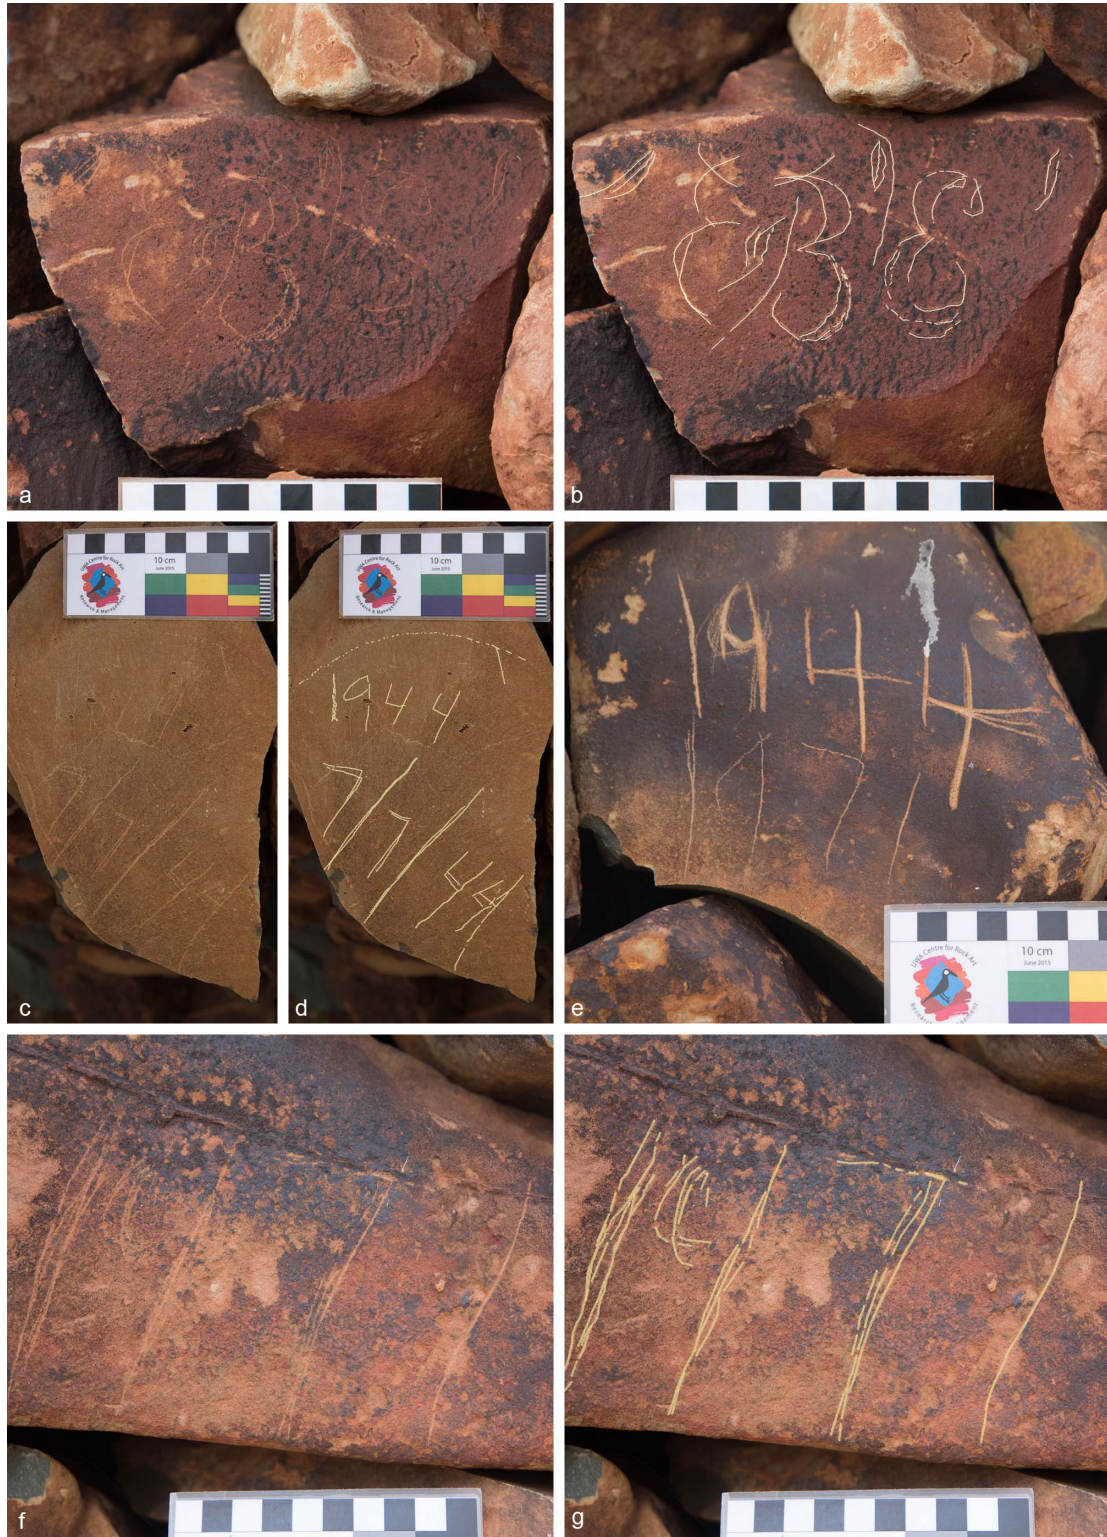
Figure 11.18. European graffiti and dates across the settlement landscape showing the mixture of dates, scripts and techniques, with enhanced image: (a–b) scripted lettering B023-01; (c–d) motif B047-01 with two examples of 1944 date; (e) motifs B051-01 and -02 – a dual date inscription 1944 and 1971; and (f–g) motif B050-01 1971 date.

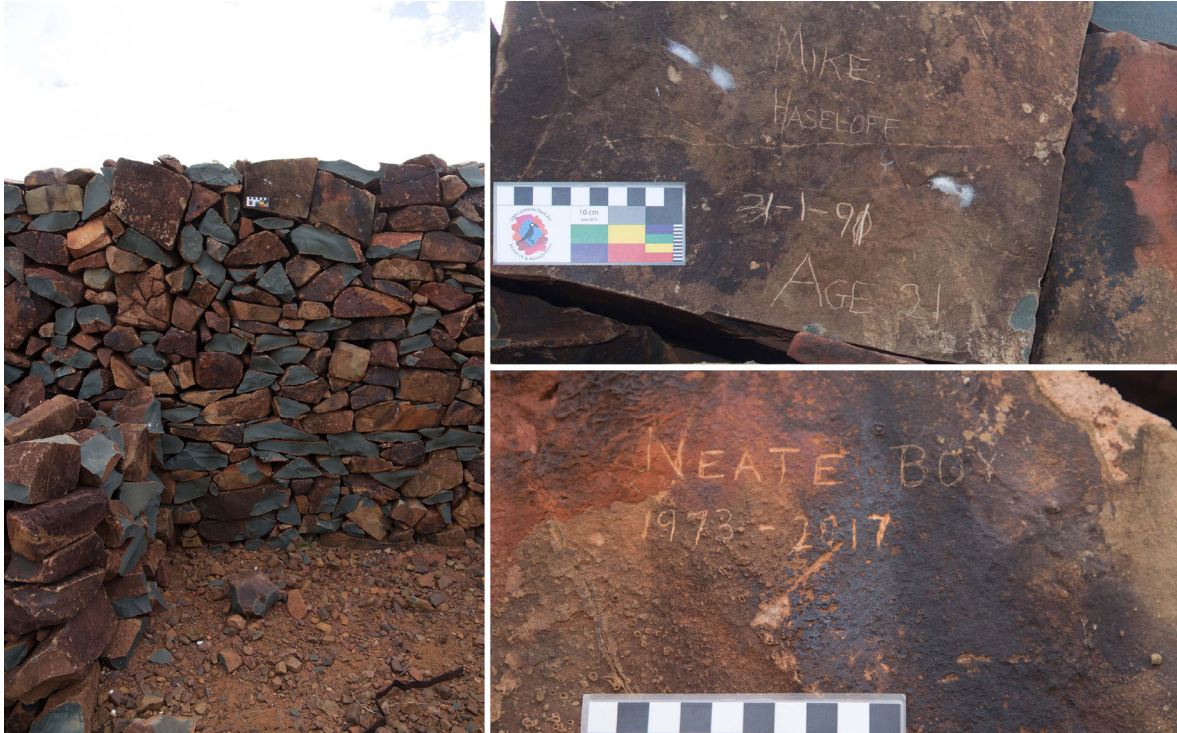
Figure 11.19. Panels B048-01 and B049-01 showing their relative proximity and location on top of a built wall displaying recent graffiti 'HASELOFF' and 'NEATE BOY'.

A motif on Building 7 exhibits 'E B E' in an ornate 'script' with floral embellishments. This looks like the oldest of the inscribed alphanumeric, but is unfortunately not accompanied by a date. Three of the inscribed dates are from 1901 – likely all from Tunney's expedition (Figure 11.19). Three motifs on Building 5 are dated 1944. The name 'Blair' is accompanied by the date 7-8-44, although these are produced in different styles of script and likely with different instruments. The 1944 dates could be attributed to the survivors of a plane wreck of a US Navy Catalina flying boat on the eastern end of Enderby Island (Paterson 2006: 100; Souter and Paterson 2004: 20). Morris (2000: 16) proposes that this wreck belonged 'to the 10th Air Wing of the United States Navy which operated from Crawley Bay (Perth), Geraldton and Exmouth between 1942 and 1944'. This Catalina was involved in night bombing raids and reconnaissance over Timor during the Second World War (Burcham 2019; Morris 2000; Souter and Paterson 2004), and was forced to put down in the waters of the Dampier

Multiple '1971' inscriptions may correspond to David Hutchison's visit to the island (in June 1971) to evaluate the condition of the settlement buildings (McIlroy 1979: 68). More recent inscriptions (over the last 20 years) were most likely made by recreational fishermen visiting the island (Figure 11.19).

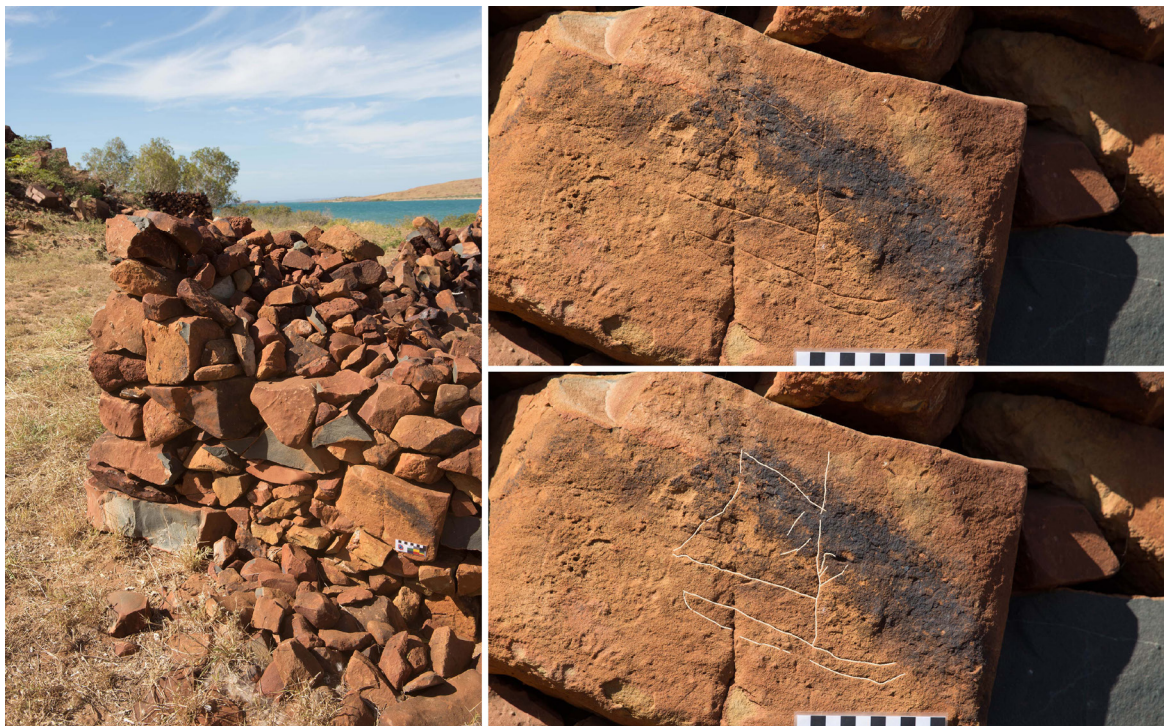
Figure 11.20. Panel WLA01-2017-B006-01 showing placement context (left) and motif closeup (sketch and *original*).

Four boat motifs are identified at the settlement. All have been produced using a scratching technique and have a linear and outline forms. Three are located on buildings, the fourth is located on the adjacent outcrop (see Figure 11.20). Boat motif B006-01 is located on a square block on the outside corner of Building 2. This is a depiction of a single-masted vessel with a single gaffe-rigged sail. The hull of the vessel is visible but there is no rudder nor any details of bow or stern section

(Figure 11.20). Boat motif B053-01 is located on an angular block on Building 5 (Figure 11.21) on the outside southern wall close to the eastern corner. This motif is the most detailed boat image depicting a single-masted vessel with both a front and rear sail, and rigging. The hull has a bisecting line, and this depiction has a rudder, bow and stern. The level of detail, particularly of the bow and stern sections, rigging and rudder, suggests a familiarity with the vessel.

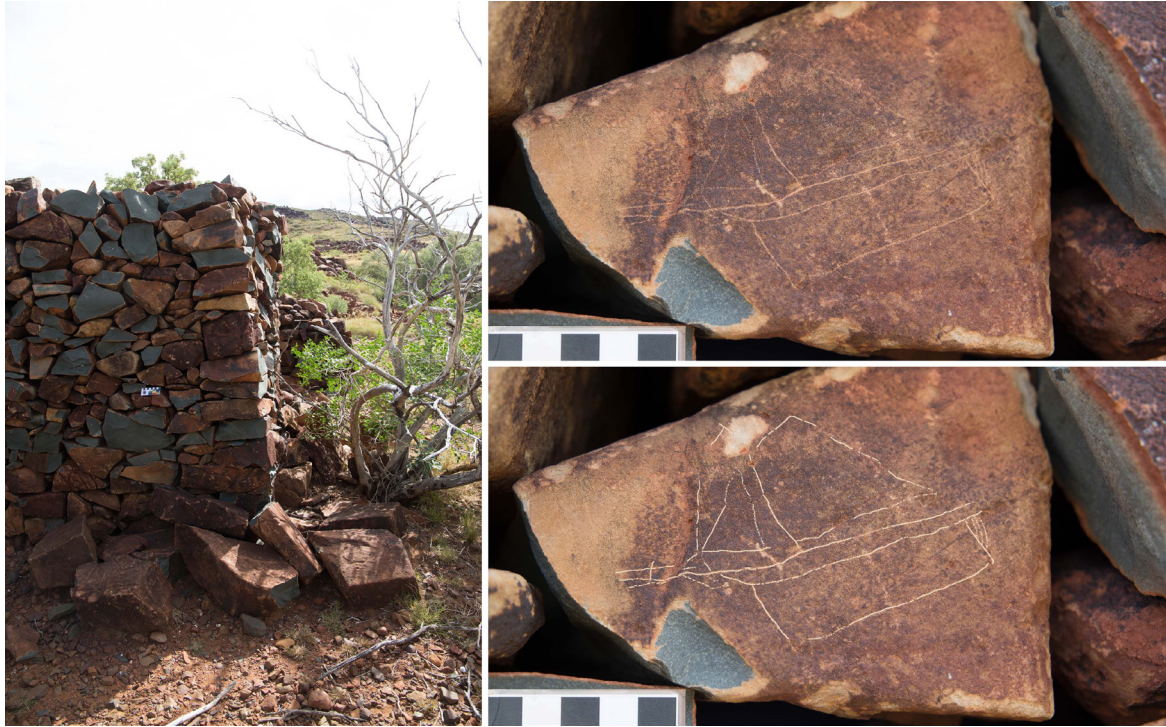
Figure 11.21. Panel B053-01 showing location on Building 5, with camera facing north (left) and detail of the boat motif (right).

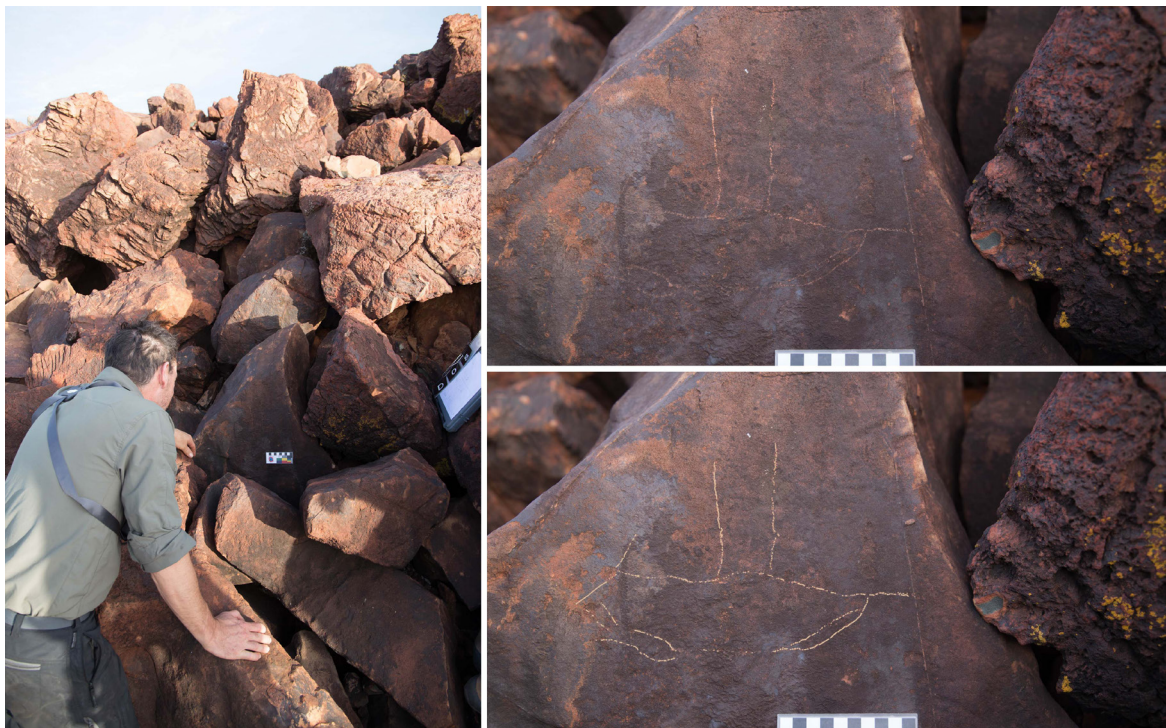
Figure 11.22. Perspective from panel D090-01 overlooking the passage between West and East Lewis islands (left) and boat motif (right).

The third clear boat engraving (D090-01) is inscribed on the lower rocky slopes, close to buildings 3 and 4. The panel faces east, towards the passage between the Lewis islands (Figure 11.22). This motif depicts a vessel with two irregular masts. No sail is discernible in this motif. Several of the lines around the hull indicate corrected lines, reflecting either the awkwardness of

inscribing onto this surface or possibly an unfamiliarity or awkwardness with the material, possibly wire, used to produce the motif. There is an extension line from the stern section, indicating possibly either rigging or an incomplete rear sail. The two masts may indicate this was a pearling lugger.

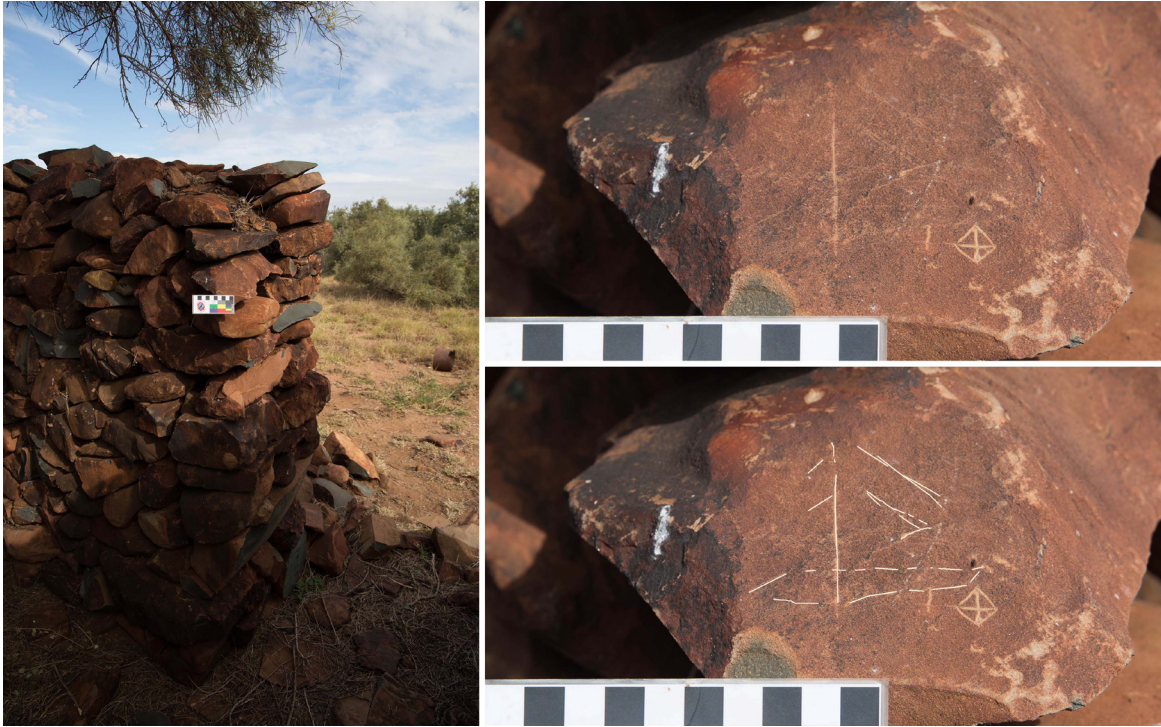
Figure 11.23. Panel B012-01 showing location on Building 2, with camera facing north-east (left) and detail of the boat motif (centre) and geometric motif (right).

A fourth boat (B012-01) was identified during the post-fieldwork photograph audit (Figure 11.23). This is located on a doorway in Building 2. It has a strong vertical line and multiple fine lines making the 'sails' and 'hull', plus other scratchings. There is a much clearer (more recent?) geometric symbol (B012-02) also made on this panel with wire.

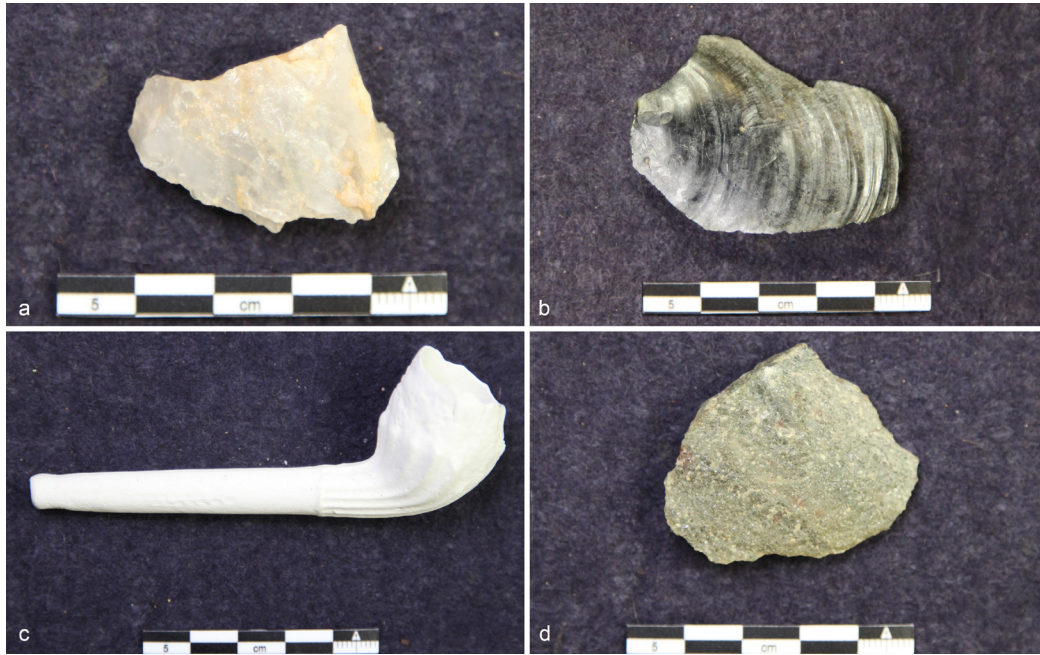
Figure 11.25. Selection of finds from West Lewis homestead: (a) quartz bipolar fragment collected during surface survey; (b) ventral surface of olive bottle glass flake; (c) clay pipe collected from Square 327249A with major erosion to upper section of bowl; and (d) indurated sandstone flake from Square 334243B XU01.

surface assemblage consisted of olive bottle glass, ceramic sherds (72.8 g) and several flaked artefacts, including two of basalt, one quartz core fragment and one piece of worked glass (Figure 11.25).

and glass fragments. Organic material included 1.3 g of pearl shell. Four quartz flake fragments were found in 327249A (one each in XUs 02 and 03, and two in XU04). Olive glass was present as well as several clay-pipe fragments in 327249A (Figure 11.25). One 22 mm bullet casing was also found 327249A.

A sizeable number of stone flakes in a variety of materials were found in Square 334243B, although less than were found in subarea B ($n = 111$). This included three chalcedony flakes (in XUs 01, 03 and 07) and a single indurated sandstone flake (Figure 11.25d). Charcoal was present throughout, as was some resin and two bullet casings. Many of these lithic items are thought to relate to the wall construction and dressing of local stone.

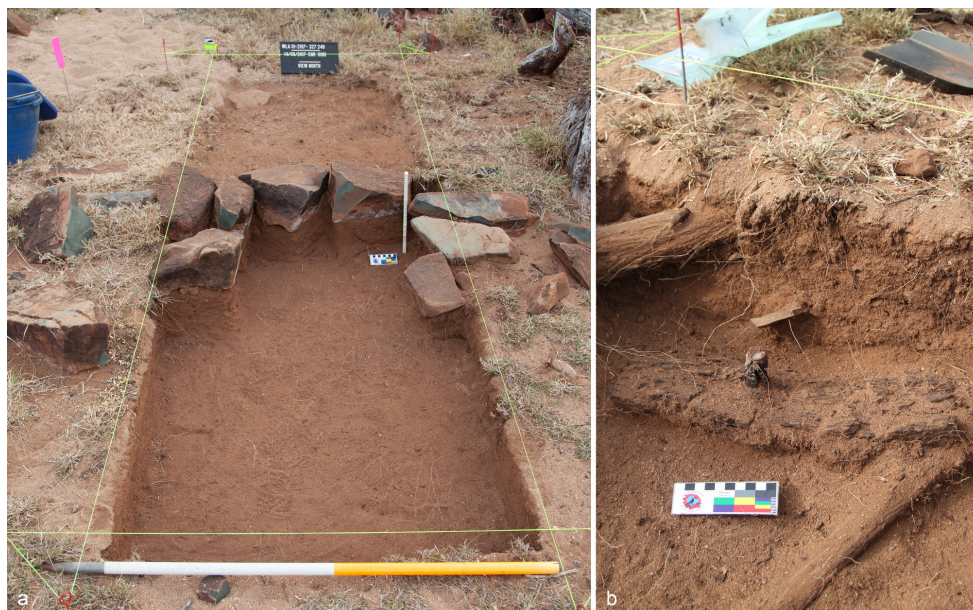
Figure 11.26. Square 327249 A and B (facing north), showing (left) excavation on either side of a stone barrier feature; and (right) timber with bolt embedded (MLP-WLA01-20170614-327249A-XU03-Bag11-7), excavated from the north-eastern corner of 327249A.

Window glass and timber were recovered from both subsquares, as were ferrous materials and nails. Bolts and timber were also found in the northern half (A) of the square (Figure 11.26), while they were not present in the southern half of the square. Clothing items include the fragment of a shoe heel and two buttons (one in each section of 327249), along with domestic ceramic sherds

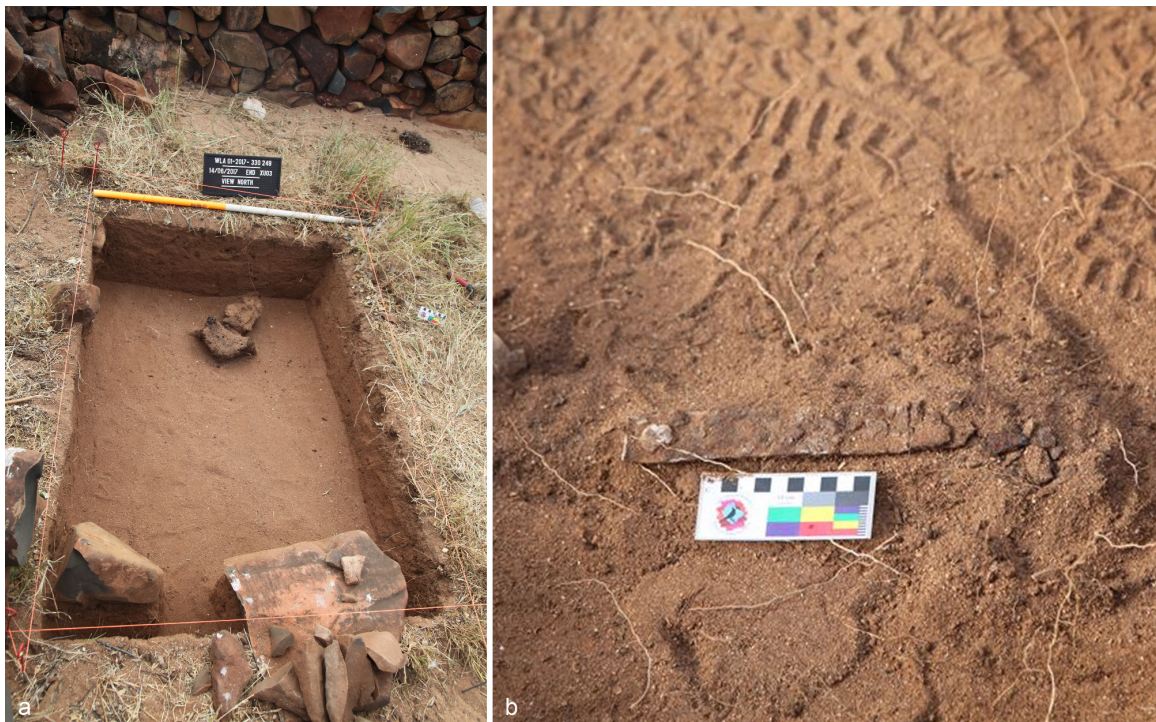
Figure 11.27. MLP-WLA01-20170615-330249-XU03-5: (left) Square 330249 end of XU03 (view north) and (right) ferrous strap/fixture found within Square 330249, XU02.

Metal artefacts were common and included bolts, wire, ferrous nails (45) and copper nails (15). Rusted ferrous fragments (2,500 g) included a rusted lock and ferrous strapping/fixture (see Figure 11.27). No clothing-related artefacts were found here. Domestic items included ceramic sherds (16.3 g), glass (7.1 g), the base fragment of a ferrous container (63.9 g) and a Griffin & Co. bottle seal made of lead. Olive bottle glass was also present.

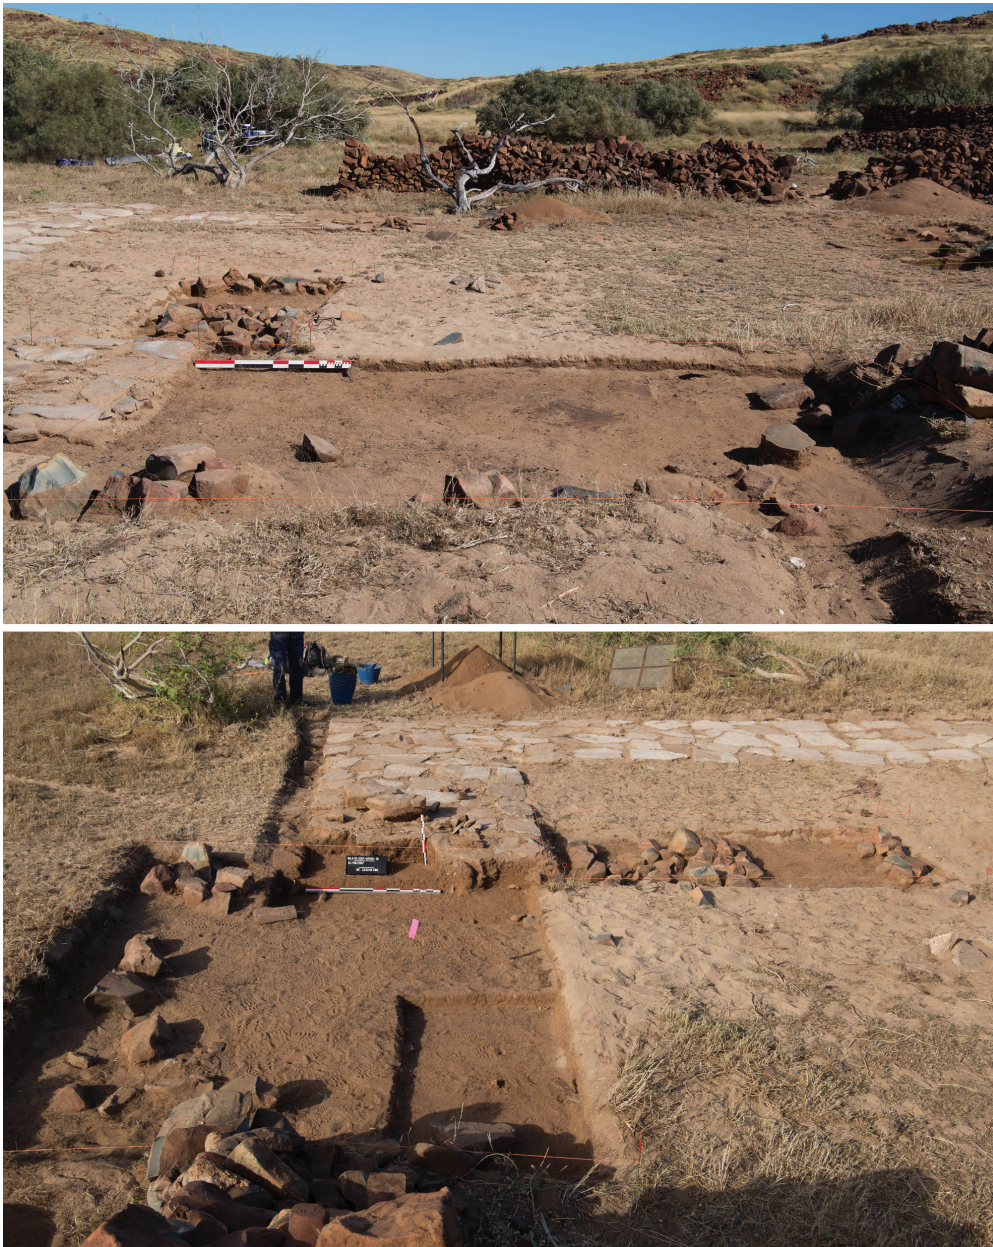
Figure 11.28. (a) Square 334243 view west, end of XU03; and (b) subdivisions of Square 334243, view south.

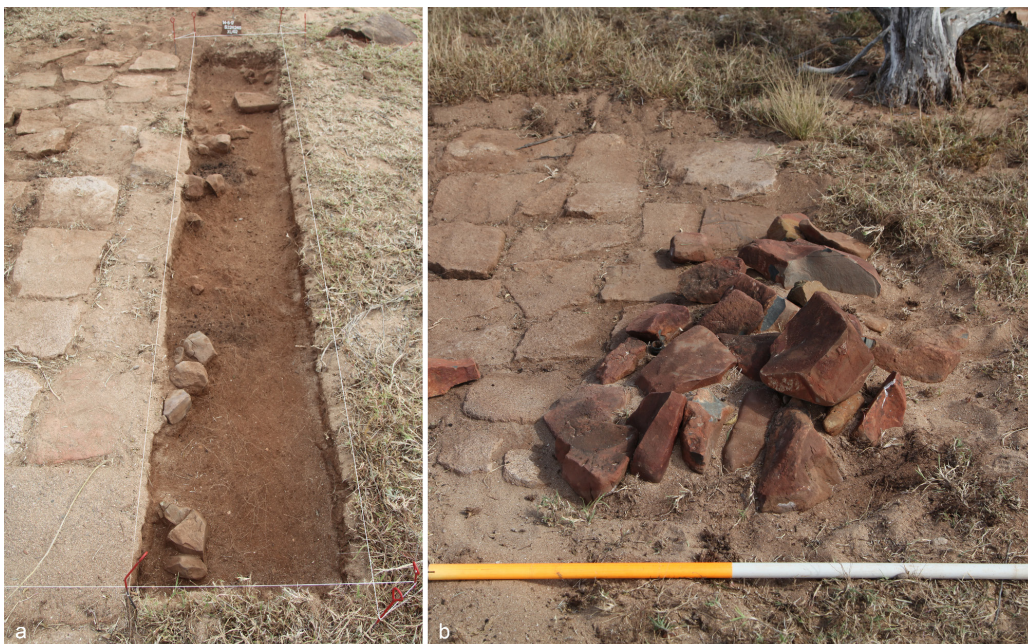
Figure 11.29. WLA01-2017-326240 showing (left) location of posts and (right) a stone pile.

Feature 19 was a low blocky stone arrangement (see Figure 11.29). Multiple methods were used to record this feature. The surface of the feature was swept and sieved. Excavations of the feature's exterior (see Figure 11.30) involved three collections: the eastern exterior (CF001-19EI), southern (CF001-19S) and a north-western excavation (CF001-19NW). These three excavations formed a narrow excavation trench around the exterior of the feature. The collection here included the smallest number of ferrous nails from Building 1 ($n = 69$), and a rusted metal bracket and some bolt fragments (460

excavation units. The square was initiated to find further traces of structural features, such as posts and stone piling (Figure 11.29).

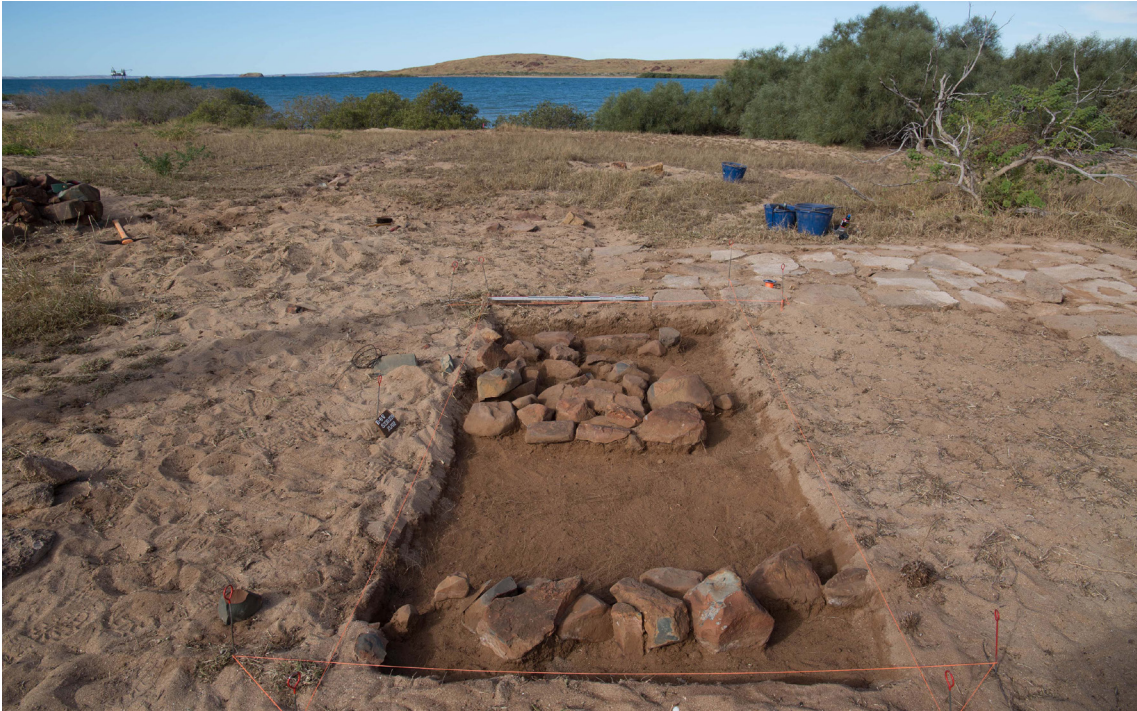
Figure 11.30. Square 330239-XU02, end level (BLD1), view east, showing two stone elements assumed to be internal structure foundations.

Square 330239 was 3.0 m x 1.5 m with two XUs. Two stone features were revealed by this excavation (Figure 11.30).

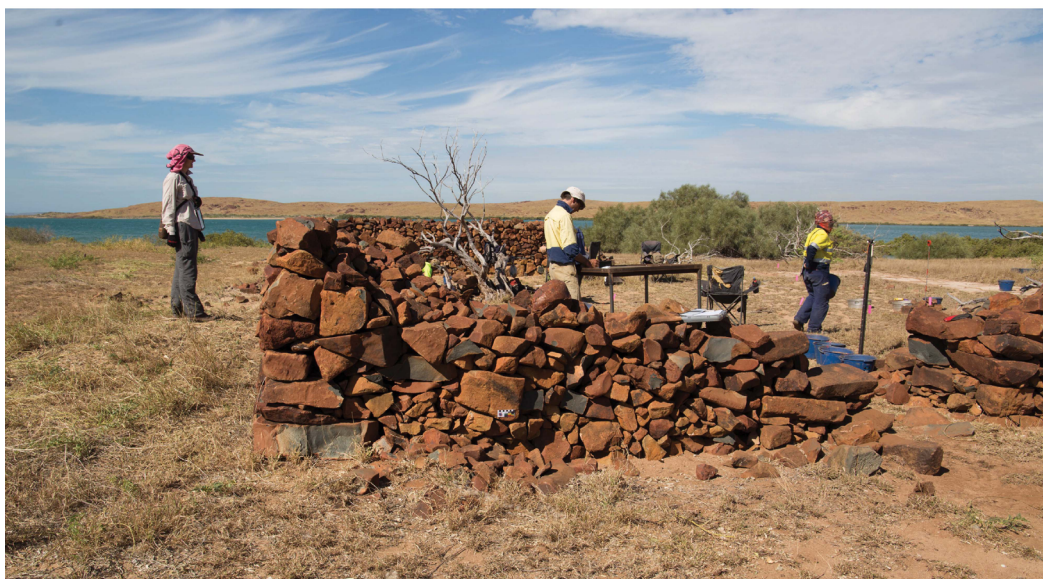
Figure 11.31. WLA01 Building 1: (top) line drawings of the petroglyphs present on the stones; and (bottom) during excavation, showing context for the boat (B006-01).

Nine motifs were recorded on Building 1 (Table 11.7 and Figure 11.31). These include two European inscriptions 'Sustenance' and a sailing boat. Sustenance was a man known to have procured Aboriginal workers for the pearler Chapman, mentioned in the Colonial Secretary Record (CSR) files detailing the murder of Cooramarra – a Beagle Bay man – by Edward (Ned) Chapman on Lewis Island in June 1877. Chapman's procurement of Aboriginal workers from Sustenance was a breach of the *Pearl Shell Fisheries Act* (CSR vol 877, p. 100 [5/11751 No 2310]). This incident is discussed more fully in Chapter 18.

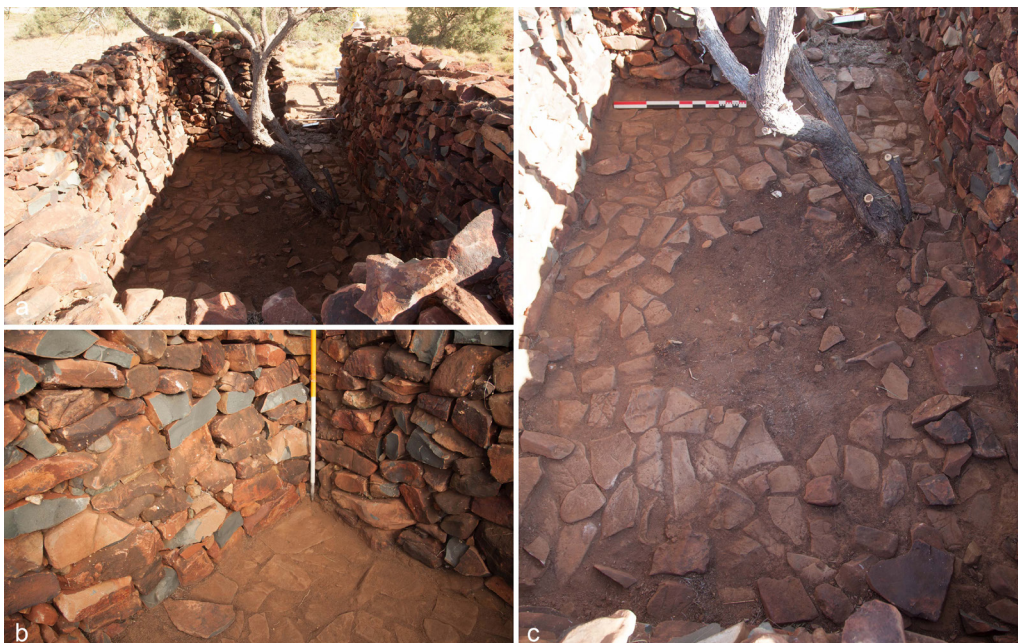
Figure 11.33. Building 2 interior ashowing entrance and tree now growing inside; (b) the cleaned southeast corner and (c) extensive flagging revealed by the floor sweep collection.
