**West Lewis
Island Pastoral
Station
Excavation**

ALISTAIR PATERSON, ALEXANDER BURCHAM, ANNIE CARSON,
KEN MULVANEY, JO MCDONALD

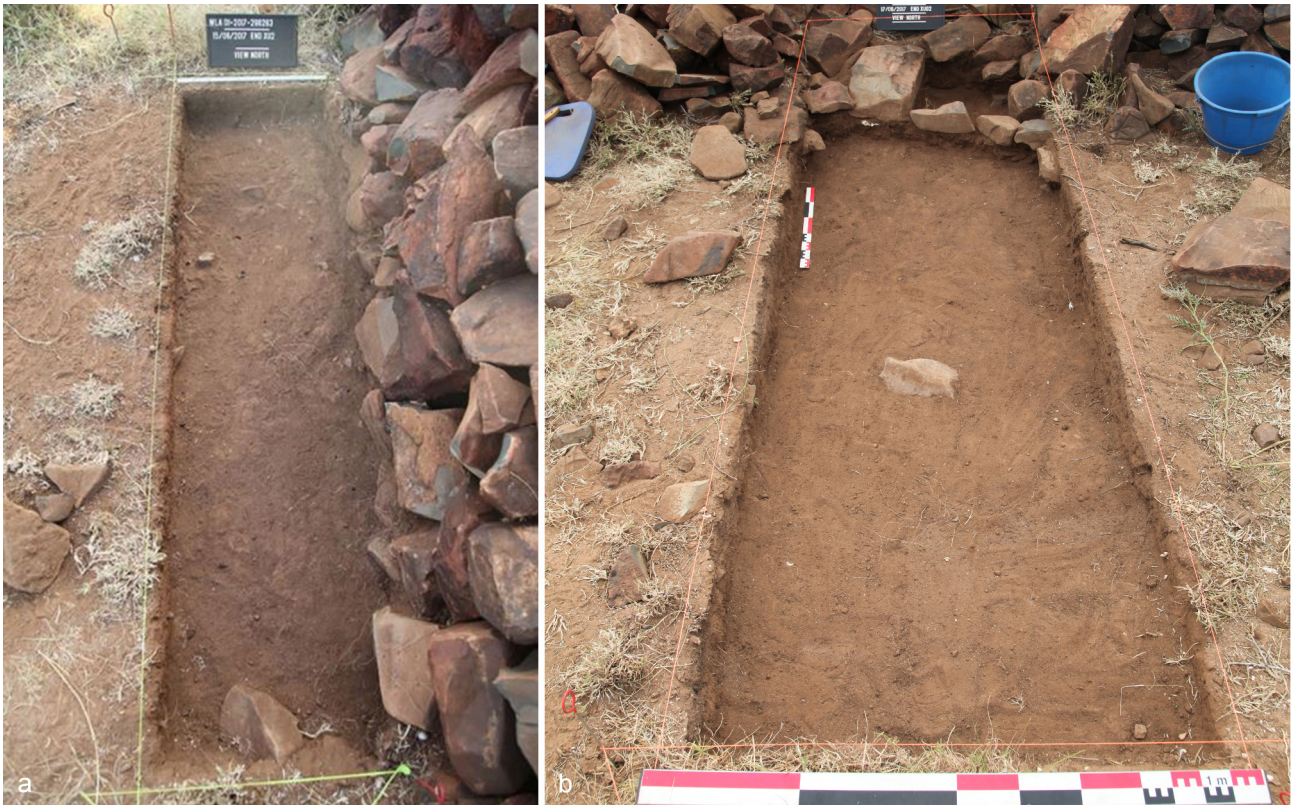
Figure 11.34. West Lewis settlement Building 2: (a) Square 298263, end of XU02 (view north); and (b) Square 300261, end of XU02 (view north).

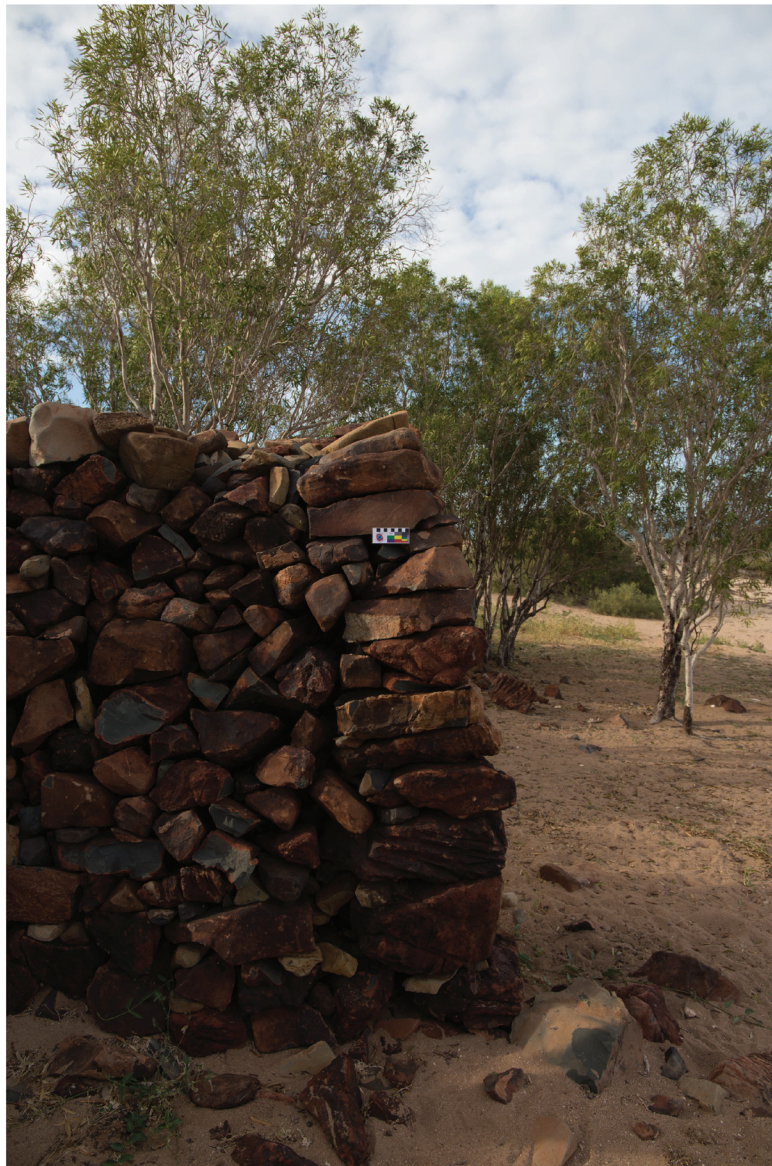
Figure 11.35. Building 2 view to the east: graffiti and Aboriginal motifs, with photo showing context for Panel B020.

Twelve motifs were recorded on Building 2 (Table 11.8 and Figure 11.35), all on interior wall surfaces, with two panels (B012 and B013) in the doorway. Several of the panels have multiple motifs on them. Marks include four European letters (three indecipherable words, and the letter D), a geometric mark and a faint sailing boat (on Panel B012). The two definitive Aboriginal motifs,

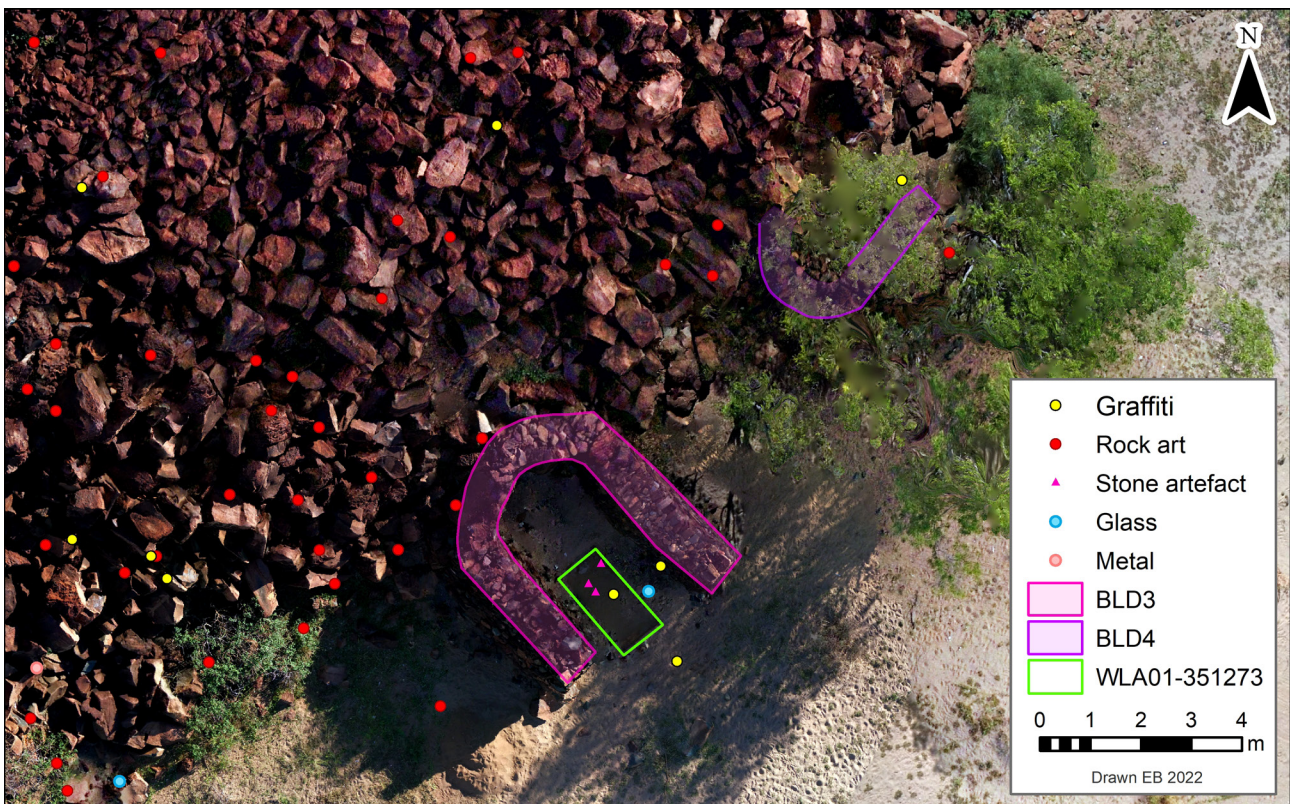
Figure 11.36. Building 3 and Building 4 with excavation location.

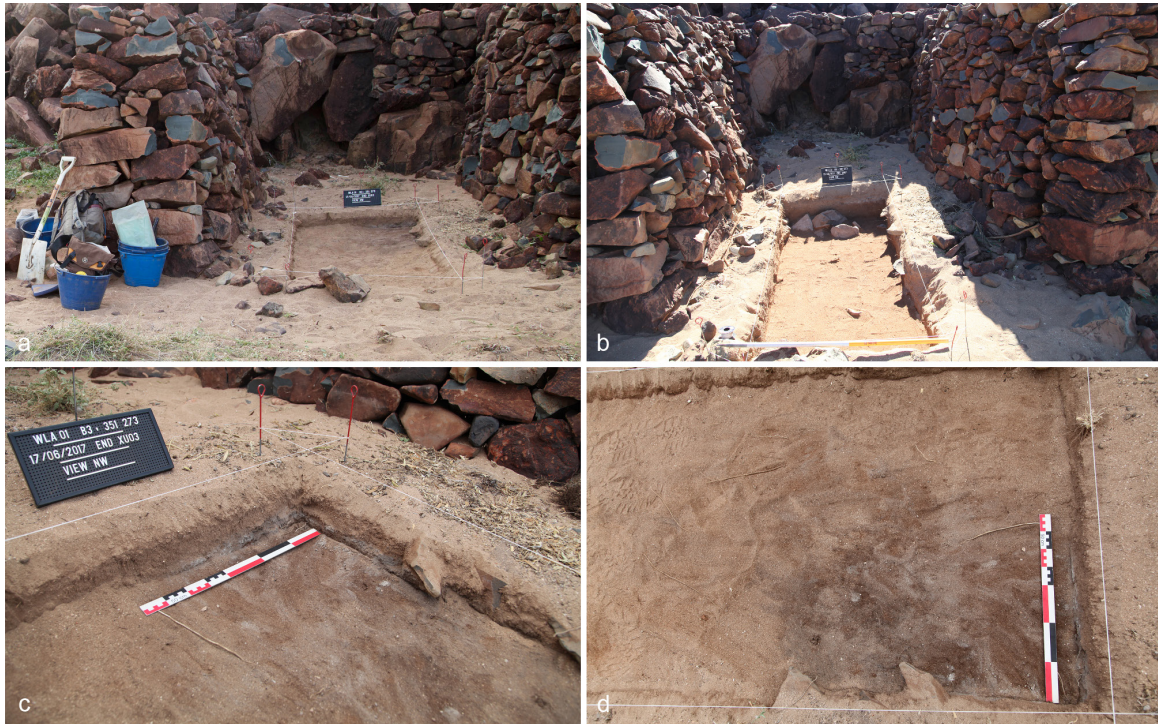
Figure 11.37. Building 3: (a, b) location of excavation; (b, d) Square 351273; (c) end of 351273XU07; and (d) detail of the charcoal rich feature encountered.

The excavation of Square 351273 (3 m x 1 m) within this building was deeper than others at the site (seven XUs). The sediment in XU01 and XU02 was fine, loosely compacted, wind-blown sand. The base of XU02 revealed a loose ashy lens (hearth?) with a very small fraction size in the south-western corner. This was excavated as a separate feature (Figure 11.37c and d).

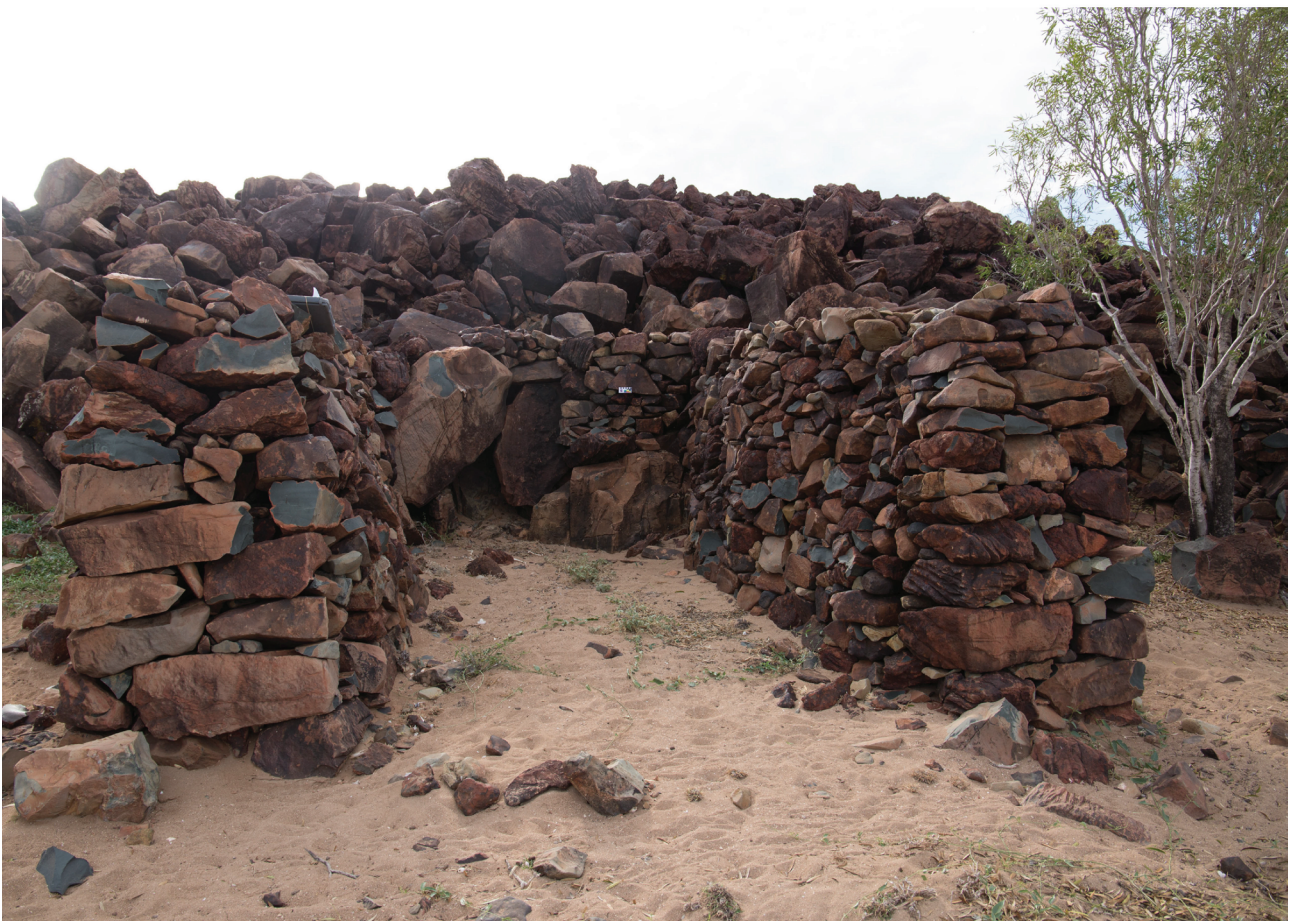
Figure 11.38. West Lewis Building 3 view to the west: graffiti and Aboriginal motifs (not all to scale), with photo showing context for Panel B015.

Six motifs were recorded on Building 3 (Table 11.9 and Figure 11.38), all scratched on the interior surfaces of the walls. One of the motifs (B019-01) is a small scratched bird track, which was likely produced before the block was moved to the building. The two 'elongated arrows' (on panel B018) could be spears or harpoon points. These may be Aboriginal in origin, or copies made by a European person. Panels B015, B016 and B017 have

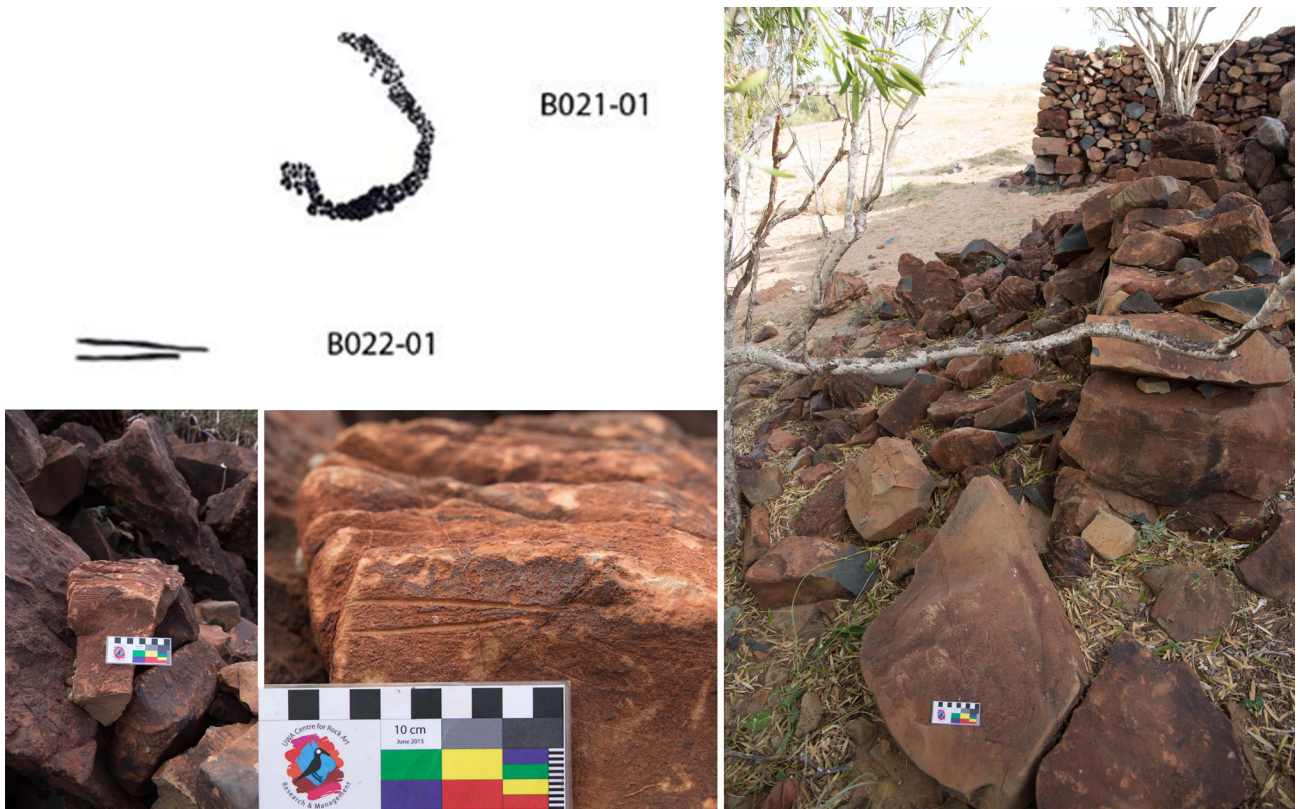
Figure 11.39. West Lewis Building 4 view to the west: graffiti and Aboriginal motifs, with photo on right showing context for Panel B021. Motif B022-01 is likely to have been incised using wire.

Two motifs were recorded on Building 4 (Figure 11.39). Both Building 4 motifs are geometric, and one (a pecked arc) is likely to pre-date the historic period. The second motif is a deeply incised converging line-set made on

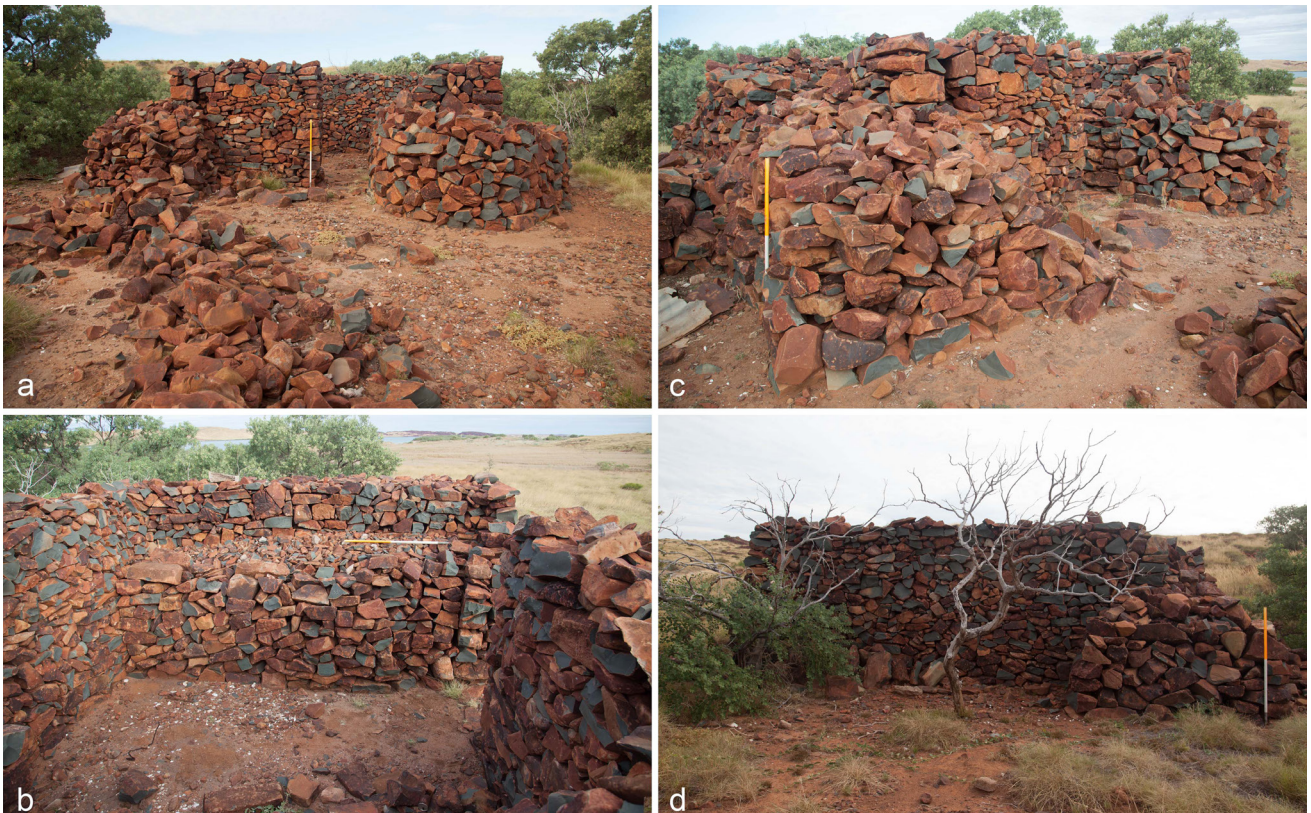
Figure 11.41. (a) View of Building 5 from the west across SWE5; and (b-d) various structural details of Building 5 during the recording.

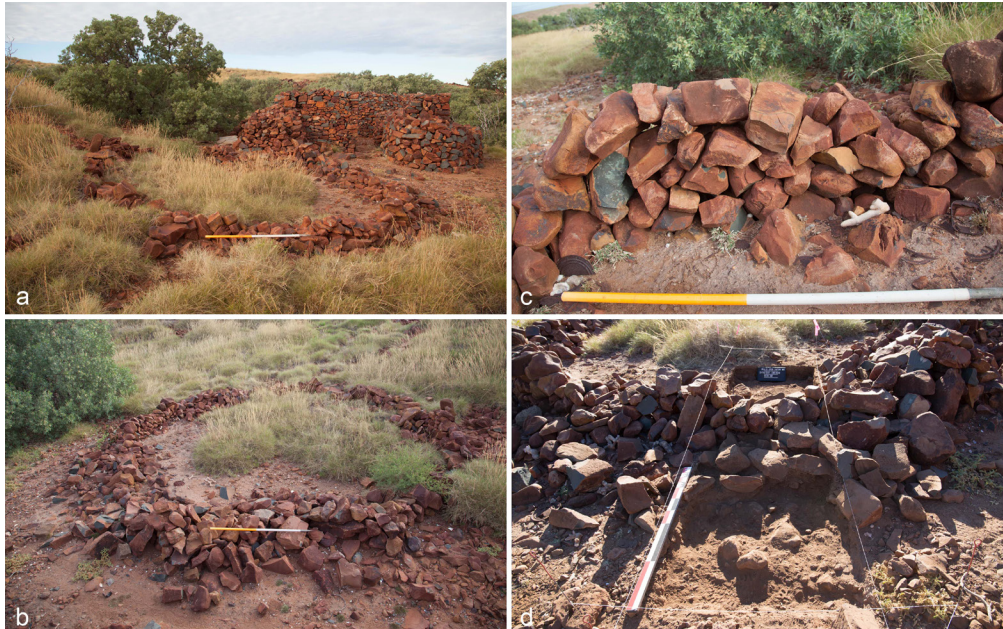
Figure 11.42. Feature SWE5: (a) view from the south with details of Square 247291 from exterior square towards interior square; (b) before excavation; (c) shows the stacked blocks in part of its construction; and (d) at completion of excavation of Square 247291.

A relatively high number of clothing items was found here ($n = 7$), including buttons, eyelets and clasps. There is a major increase in domestic artefacts compared with the other settlement buildings, largely due to the number of ferrous containers found in both the interior ($n = 12$) and exterior ($n = 2$) of SWE5. Lead seals (Figure 11.43), glass and ceramics were also found at SWE5, as were many faunal remains, including bone (11.7 g) and shell

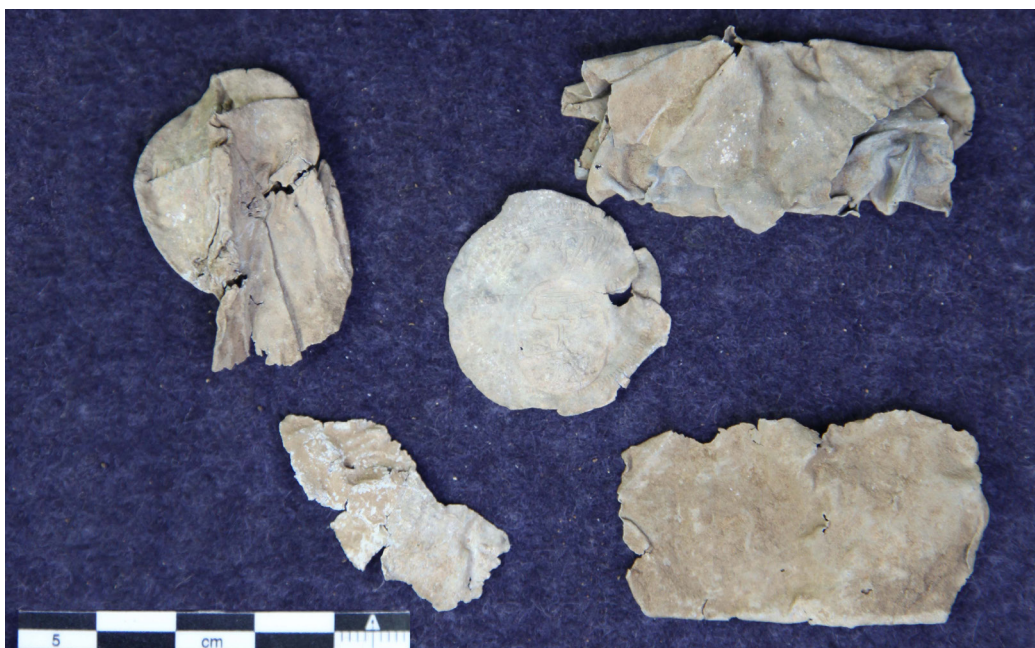
Figure 11.43. Lead seals collected from Square 247291 exterior.

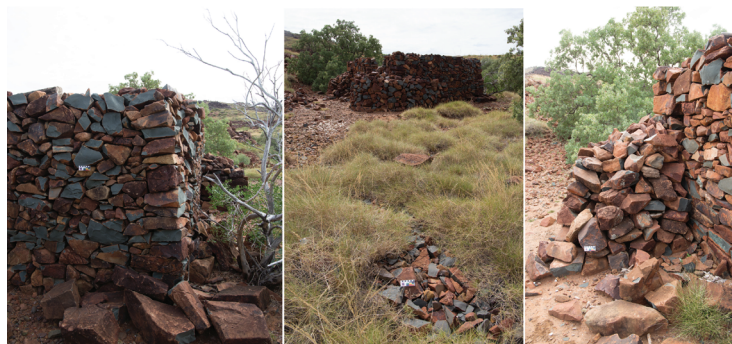
Figure 11.44. West Lewis Building 5: recorded graffiti and Aboriginal motifs, with photos below showing contexts for panels B052 (left), B060 (middle) and B057 (right).

Seventeen motifs were recorded on Building 5 (Table 11.11 and Figure 11.44) and this structure has been a focus for much of the recent graffiti production. Two European inscriptions include an indecipherable word and a sailing boat; three motifs had been moved from elsewhere at the site during construction;

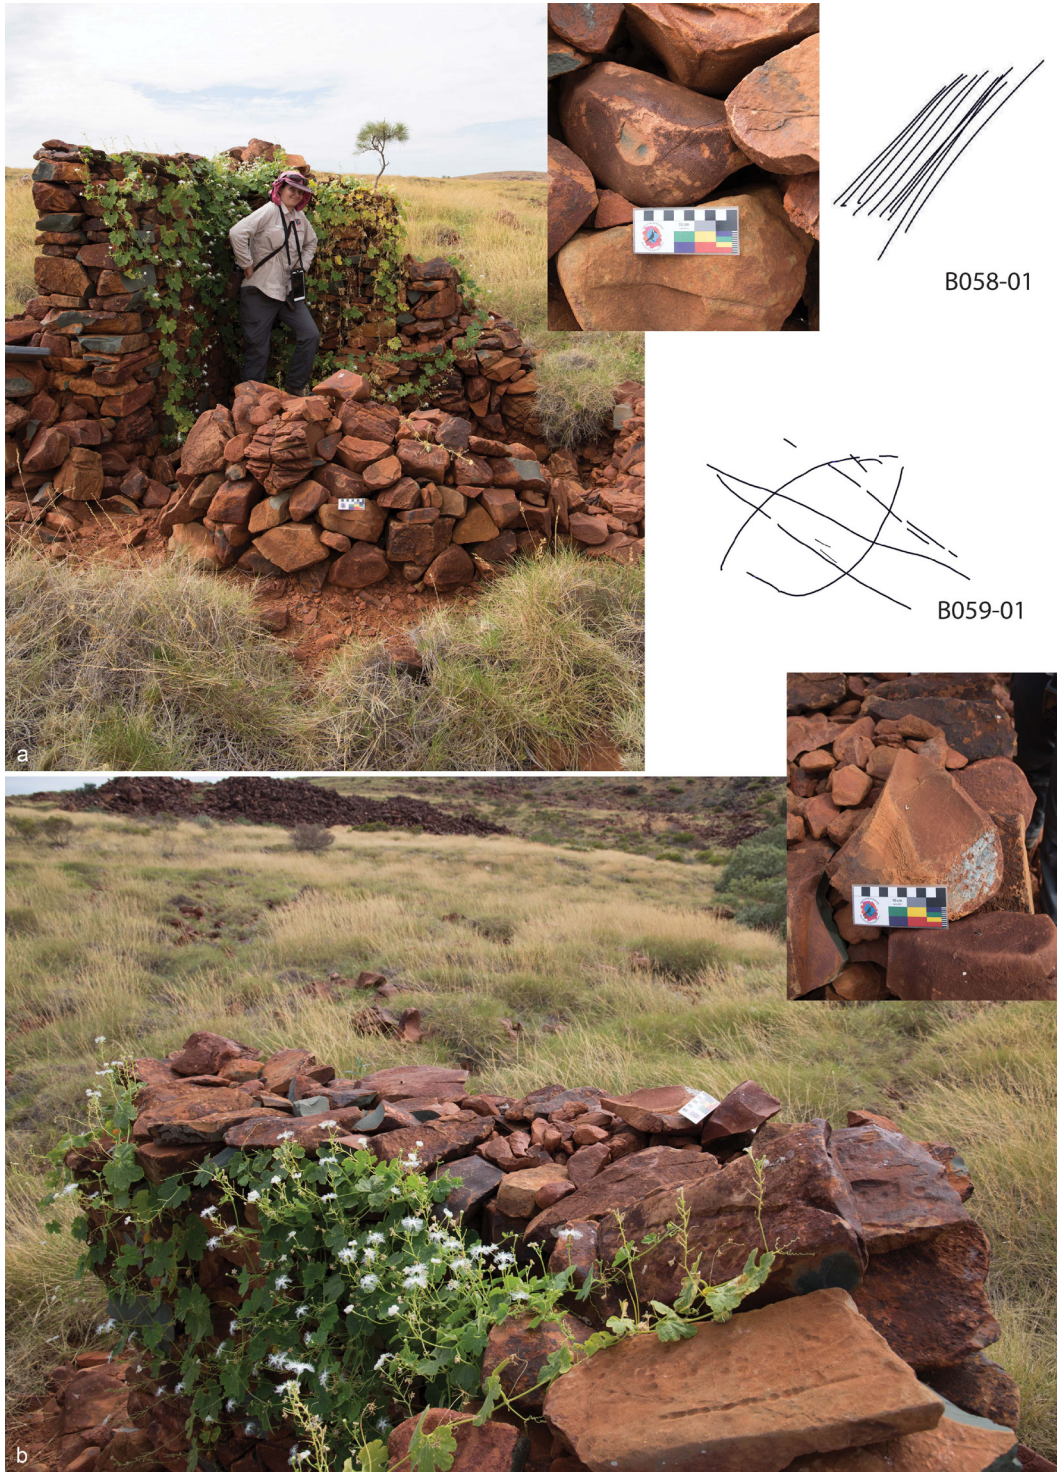
Figure 11.46. West Lewis Building 6: recorded motifs, with photos showing contexts for panels B058 (a) and B059 (b).

Two motifs were recorded on Building 6 (Table 11.12 and Figure 11.46). The directional scratching is on an exterior surface of a wall of this building, while the geometric motif is located on top of the northern wall, indicating it could have been produced here. Both motifs are

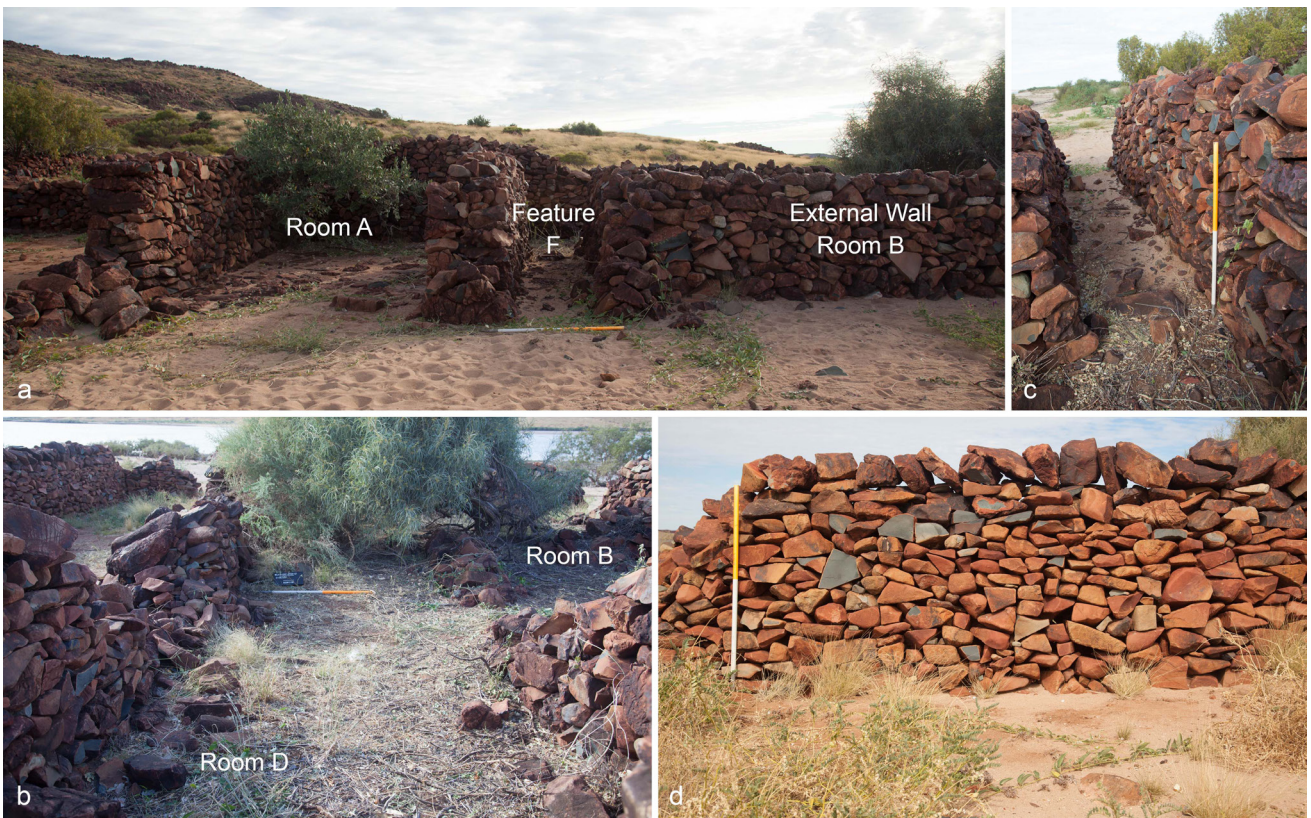
Figure 11.49. Building 7 associated with the sheepyards: (a) view north into Room A and Feature F; (b) Feature F internal, facing south; (c) Room D and entrance into Room B, view east; and (d) high external Wall 3 of Room E.

No traces of roofing were found around Building 7 by McIlroy (1979: 96) or the 2017 survey team. However, it is probable that the areas A–F (Figure 11.49) were covered by corrugated iron sheeting. Building 7 may have served various pastoral functions. Areas A, B, C and F all have cobbled floorings, suggesting areas where people worked with reduced amounts of dust inside the building. Sheep were potentially held within Room E and moved into a

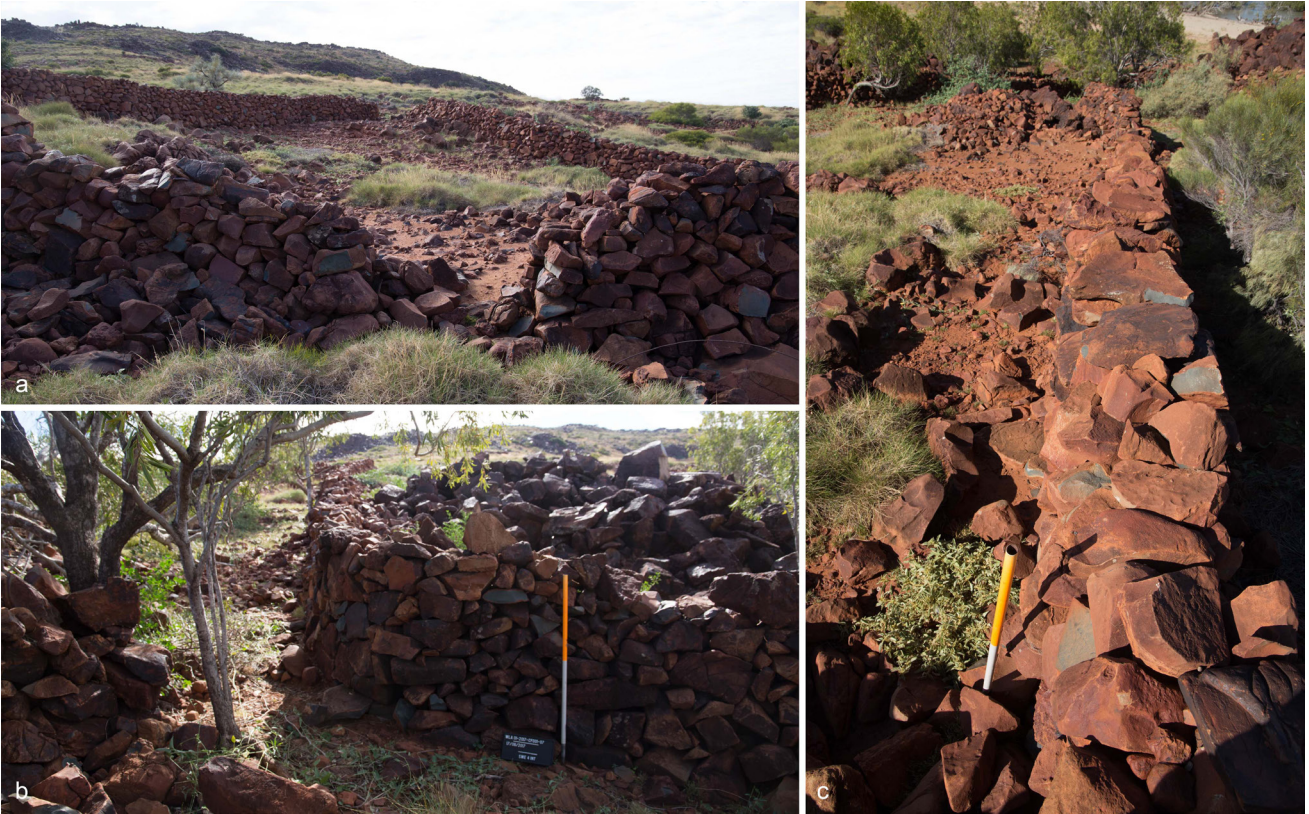
Figure 11.50. Yards associated with Building 7: (a) north-west triangular yard (SWE2) looking north towards outer gate; (b) 'choke point' entry into SWE2 from SWE1; and (c) looking east along the wall between yards SWE2 and SWE3.

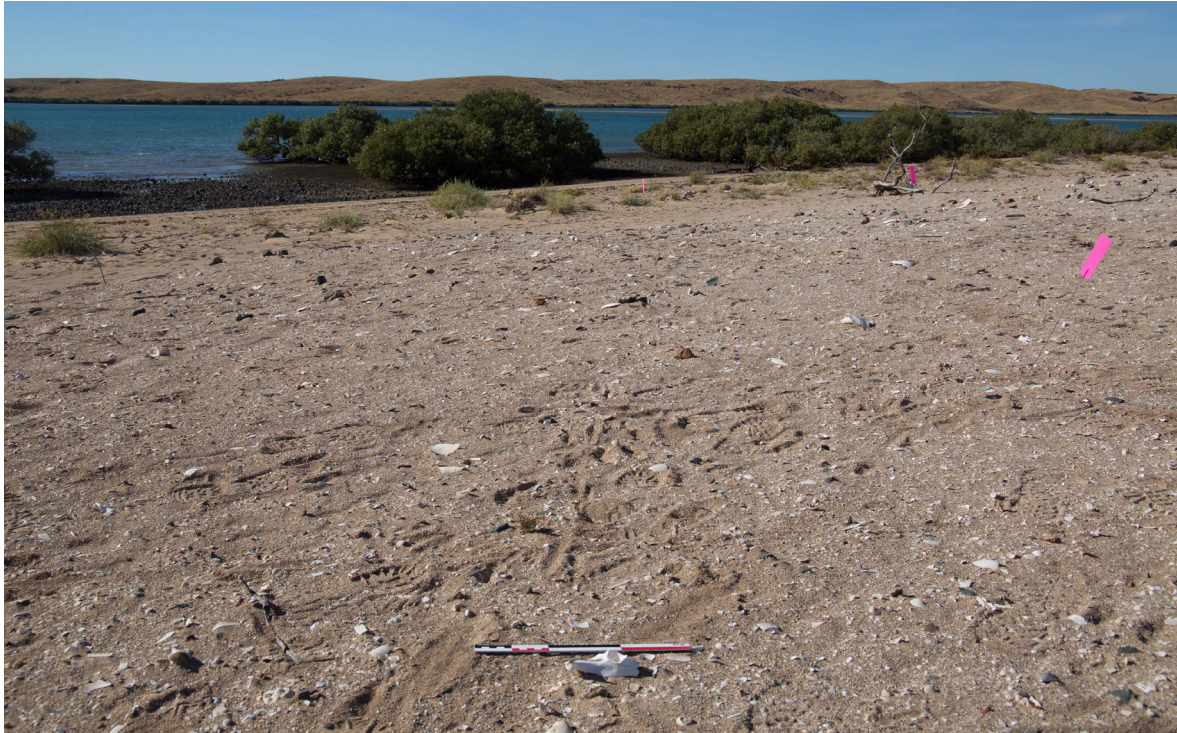
Figure 11.53. CF027 south of the West Lewis pastoral station building, midden feature showing scattered shell. Scale (10 cm) in foreground beside sheep bone.
